TECHNICAL SERVICE BULLETIN

No.LTB00052/2007

Subject/Concern:	Freelander - Fuel Pressure Sensor Repair Harness		
Model:			
Freelander (LN)	Year: 2001 Onwards Engine: Td4

Markets: All
Section: 303-14 (18 - Engine Management)

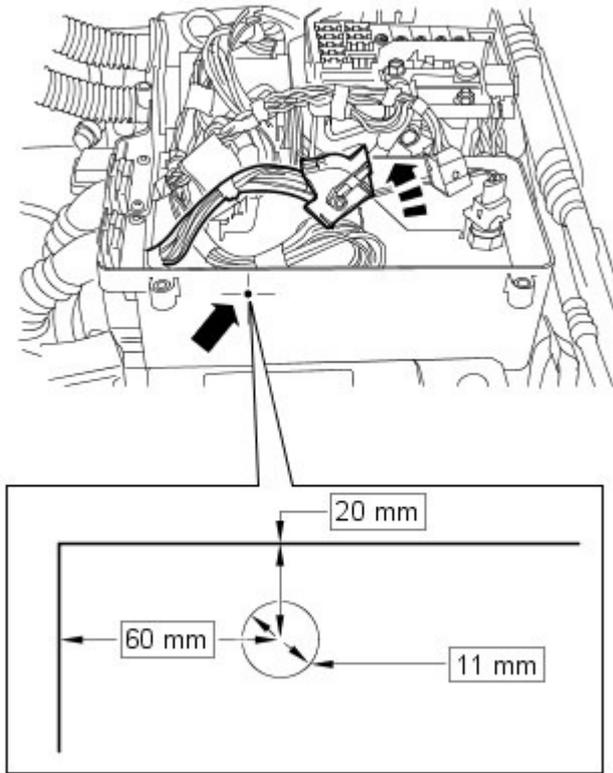
E85072

Cause: Investigation using diagnostic equipment points to the fuel pressure sensor, which when renewed can rectify the problem. However, the root cause of this issue is likely to be corroded connections in the fuel pressure sensor harness connector and renewing the sensor alone may not permanently repair the problem.

4. Drill an 11 mm hole in the side of the E-Box at the position shown.
