TECHNICAL BULLETIN

Rover 75, Rover 75 Tourer diesel

Nº: TB0090 Issue 1

MAF SENSOR CONTAMINATION - WATER SHEDDER

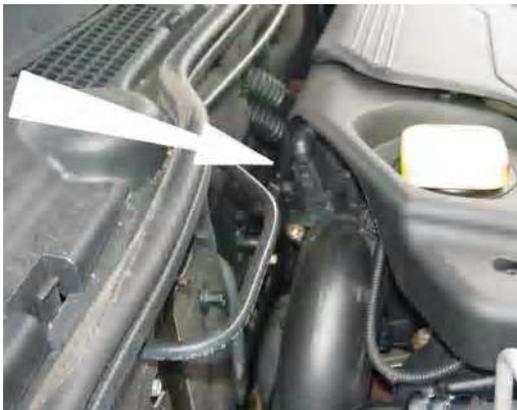
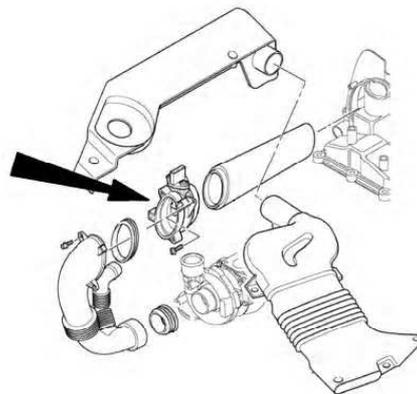
1. Remove engine acoustic cover (repair number [12.30.50](#)).
2. Remove air intake duct and air cleaner element (repair number [19.10.10](#)).
3. Remove the MAF sensor from the air intake assembly, repair number [19.22.38](#) refers (for location, see illustrations 3 and 4).
4. Fit exchange MAF sensor MHK101130E and re-assemble in reverse order.

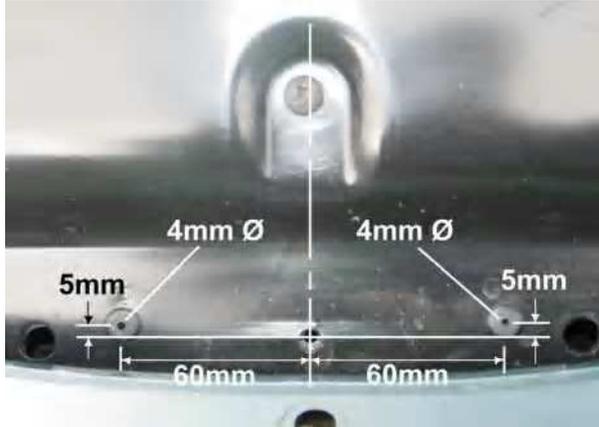
7

NOTE: The illustration shows a later stage with pop rivets fitted.

2. With the front bumper pulled and held forward (Rover models only), make 2 marks on the bonnet locking platform where the water shedder fixing holes are to be drilled. Referring to illustration 7, measure 60mm to the left and 60mm to the right of the centre line then 5mm back from the bumper fixing holes as indicated, mark where lines cross.

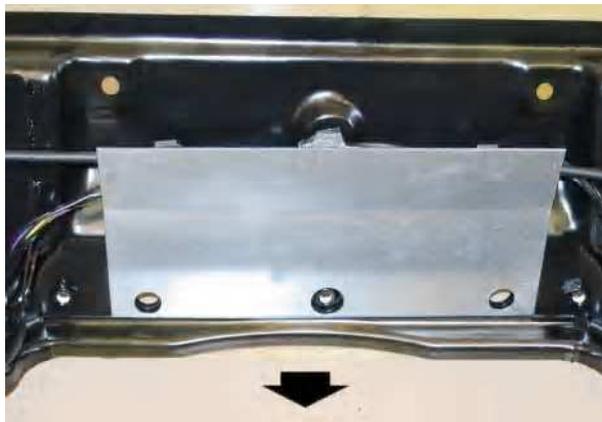
8

NOTE: The plate has been designed to locate below the existing platform wiring and clips. The large central hole in the shedder locates around the bumper fixing weld nut on the underside of platform.

3. Drill 2 X 4mm Ø holes in the bonnet locking where marked.
4. Touch in bare metal where drilling took place with anti-corrosion primer.
5. Referring to illustration 8, position water shedder (part number PHL000010) under the bonnet locking platform with its 3 large holes facing the front of the vehicle and the deflector section facing the engine and pointing down (the arrow in illustration indicates front of vehicle).
