LA501-027

# TECHNICAL BULLETIN

501-16 - Wipers and Washers

Discovery 3 - Poor Rear Wiper Performance/Seizure

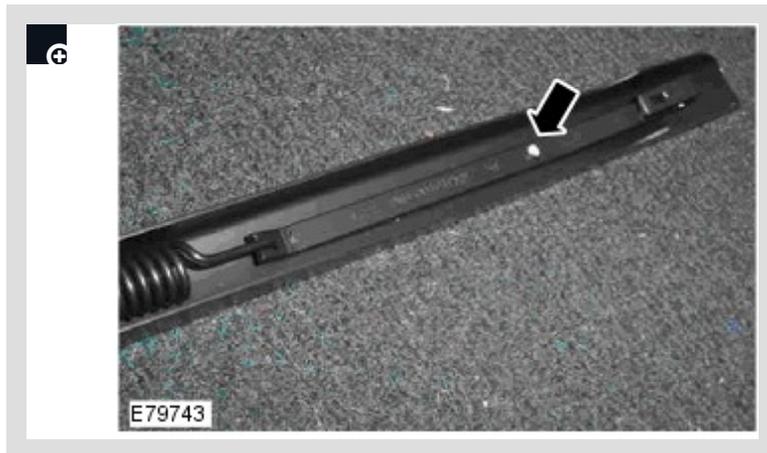
Part Number DKB500101PMD has been reworked to the new design condition (to be equivalent to the new Part Number DKB500330PMD) and can be identified by a white paint mark on the rivet (see illustration E79743).

Install a new rear wiper arm.
