## WATER INGRESS AT REAR OF VEHICLE

### TECHNICAL SERVICE BULLETIN

Reference Number(s): 76/01/03/NAS,Â Date of Issue:Â January 17, 2003

LAND ROVER: Discovery Series II (LT)

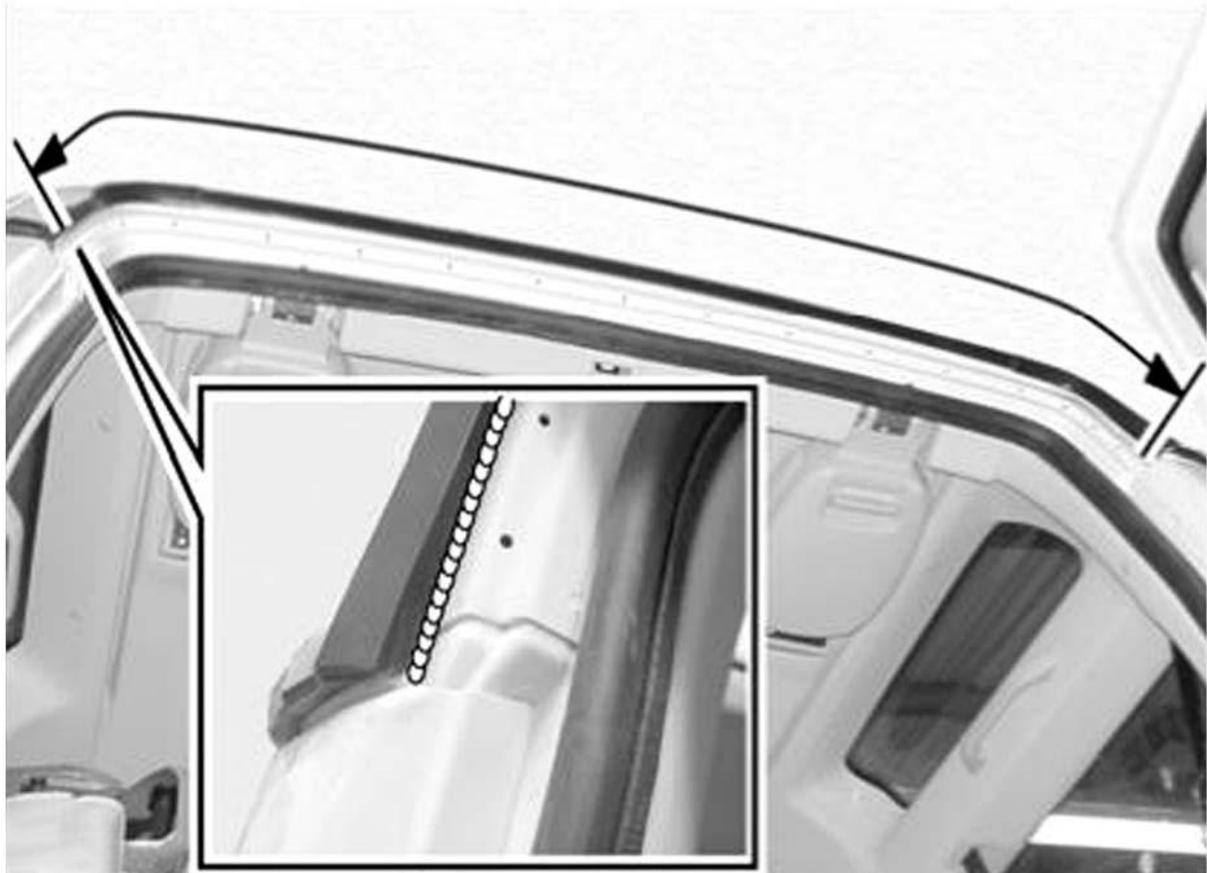
**Fig. 1: Applying Sealant Between Roof & Rear Header Outer Joint**

A sealing operation between the roof and the rear header outer joint may have been inadvertently omitted during production. The lack of sealant in the joint can permit water ingress.

3. Remove the seal.
4. Clean between the roof and the rear header outer joint ([Fig. 1](#)).
5. Apply a continuous bead of sealant between the roof and the rear header outer joint (Inset in [Fig. 1](#)).
