Mysterious [Battery](#) Drain on a P38

Diagnosis and A Novel Cure

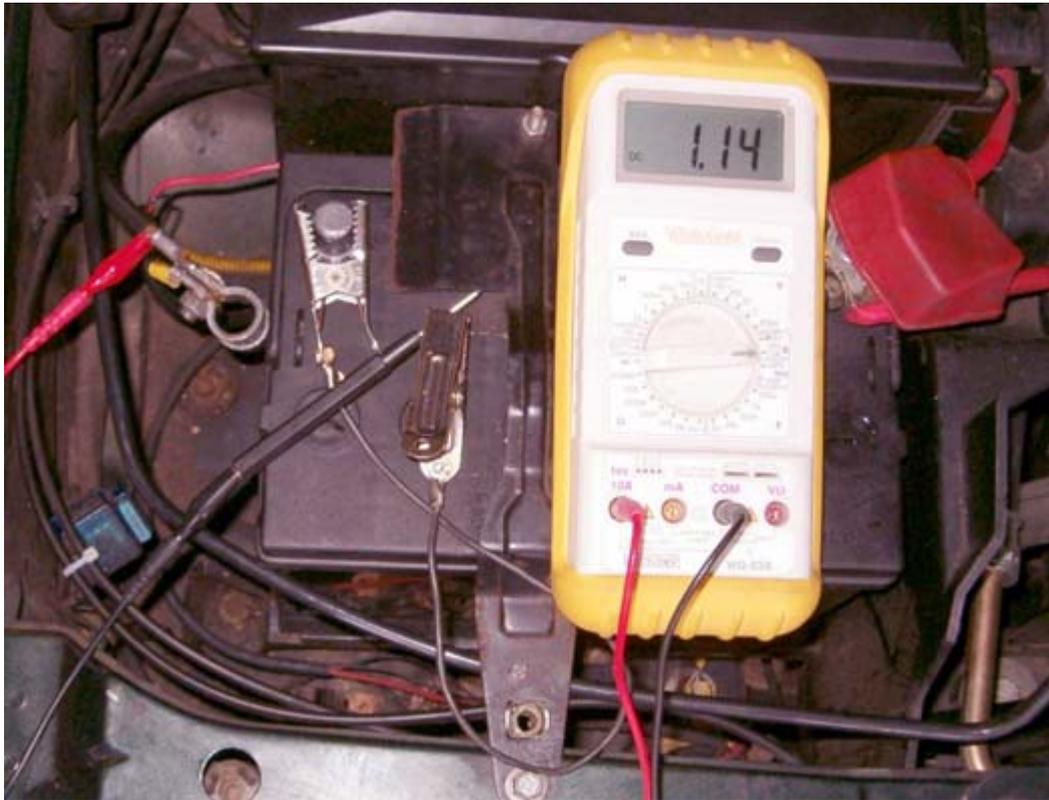
Photo at right: Andy's multimeter registers over an [amp](#) of drain with the BECM awake.

To establish the BeCM activity I used a multi-meter between the [battery](#) negative terminal and the negative lead to measure current drain. When the Rangey was shut, locked and alarmed the current drain was about 1.1A initially, then dropped to 0.57A and after 2 minutes went down to 0.02A (see photos above and below of the drain with the [BeCM](#) awake and asleep respectively). This is what Rangey should do and she had no traceable fault, as was confirmed by a Landrover main dealer. (It seems that the selected gear position LED glows very faintly as an indicator that the [BeCM](#) is awake).

Until I found the problem I fitted a concealed double pole [switch](#) to turn off the [RF receiver](#) and locked up using the key. According to the handbook the receiver draws current through [Fuse](#)15 but when that was taken out the receiver still worked so it had to be double pole. If Rangey is to be left for more than two days, I can leave her and know that the battery will be OK, albeit without the volumetric [alarm](#) armed.

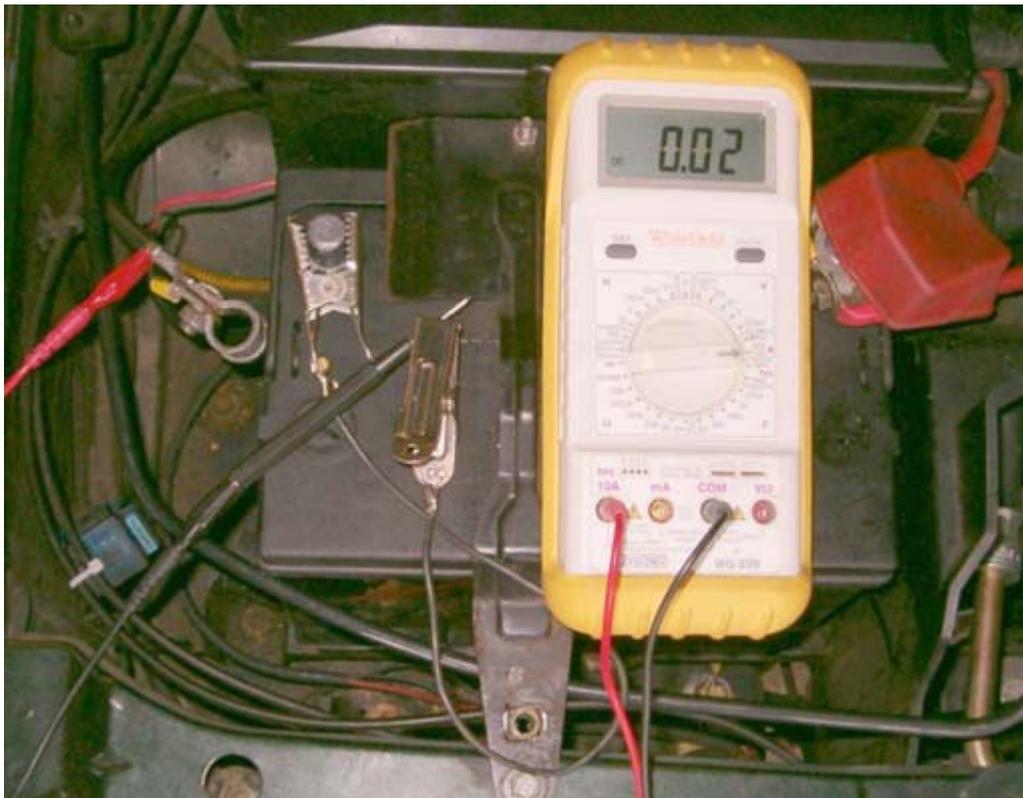
Photo: Andy's multimeter registers .02 [amps](#) (20 mA) with the [BeCM](#) asleep.

any physical action on my [part](#), the only time she slept for any length of time was when the [RF receiver](#) was disconnected which implied the RF receiver was waking it up. The aerial was disconnected, a new receiver was fitted but still a radio signal was causing the BeCM to stay awake. Using a radio frequency scanner with a strength meter, I found a strong, regular pulse from somewhere near to my home being transmitted every 46 seconds on 433.875Mhz, close to the remote key frequency of 433.92Mhz. I was able to trace this signal to a faulty [window](#) sensor for a wireless burglar alarm on a neighbour's house further up the road. When the alarm sensor batteries were changed the signal ceased and Rangey has slept soundly ever since with no more battery drain problems.
