# TECHNICAL BULLETIN

**MODEL/DERIVATIVE:**  
Range Rover

**Bulletin :** 0012  
**CDS ref:** 10483bu  
**Issue:** 1  
**Date:** 02.06.99

**PROBLEM:**  
**ELECTRONIC AIR SUSPENSION (EAS) NOISE - COMPRESSOR MOUNTS**

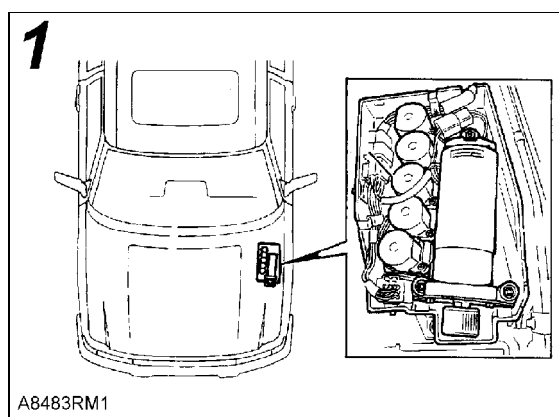
Reports of a droning noise transmitted into vehicle. The noise is apparent in the region of the front left hand corner of the vehicle and on investigation is found to originate from the air supply unit ( illustration 1 ).

**CAUSE:**  
Deterioration of the EAS compressor rubber mounts.

**ACTION:**  
Modified compressor mounts have been fitted to all vehicles from VIN XA 420550 onwards. These latest mounts can be fitted to earlier vehicles by following the procedure below:
