## WHEELS AND TIRES

# TIRE PRESSURE MONITORING SYSTEM INTEGRATED (G2016695)

### DESCRIPTION AND OPERATION

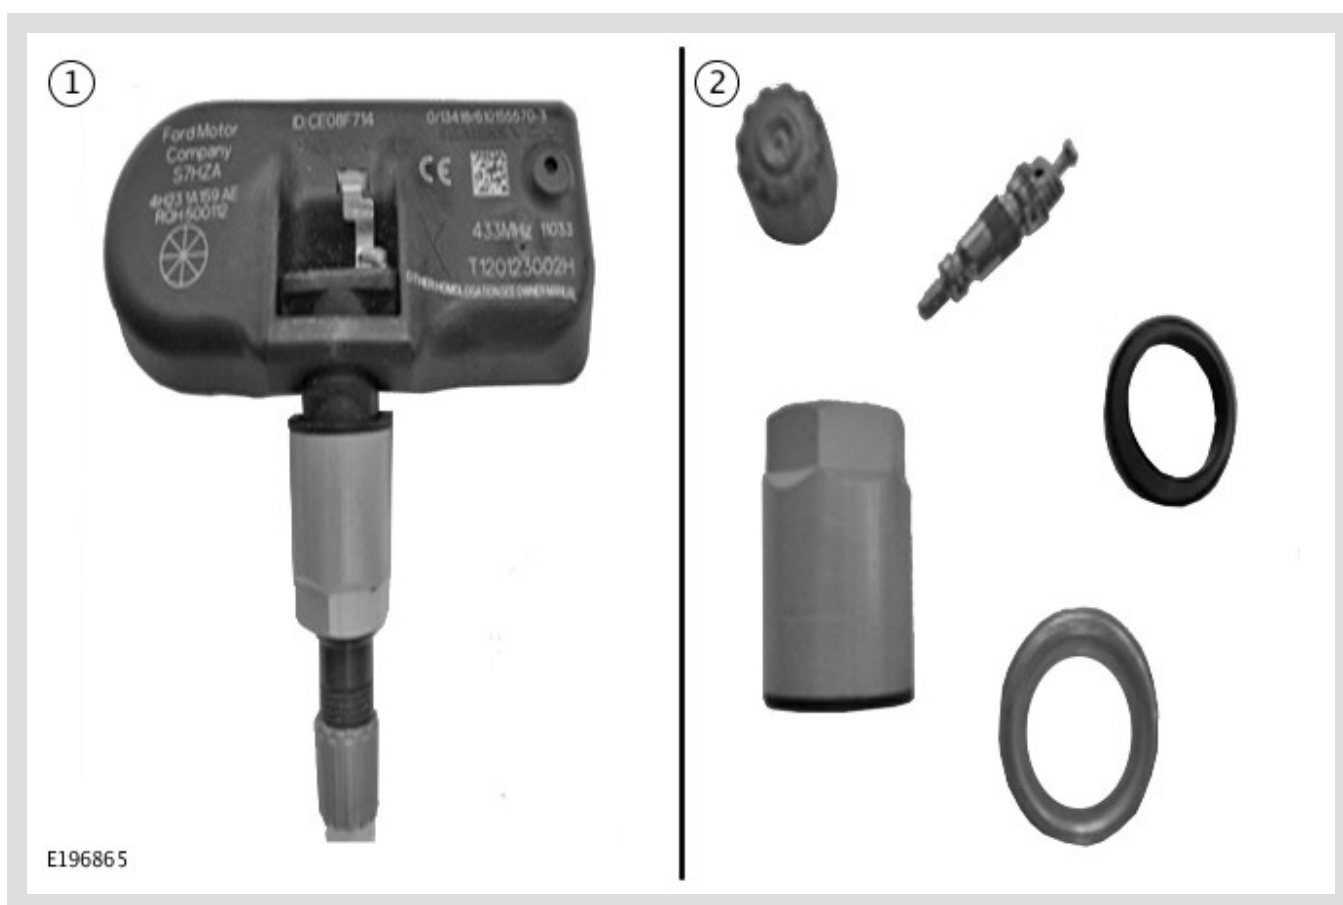
If the TPMS valve has snapped, then inspect the TPMS wheel unit and decide if it is a two part construction, or is a one piece part.

1 TG1B Valve - complete valve.

2 TG1B - Service kit.

Please note that Jaguar Land Rover does not cover the snapped/damaged TPMS under warranty, this is not a manufacturing defect.

If the TPMS wheel unit is a TG1B wheel unit, then replace the wheel unit with the same part (subject to supersession as per the Land Rover Electronic Parts Catalogue).

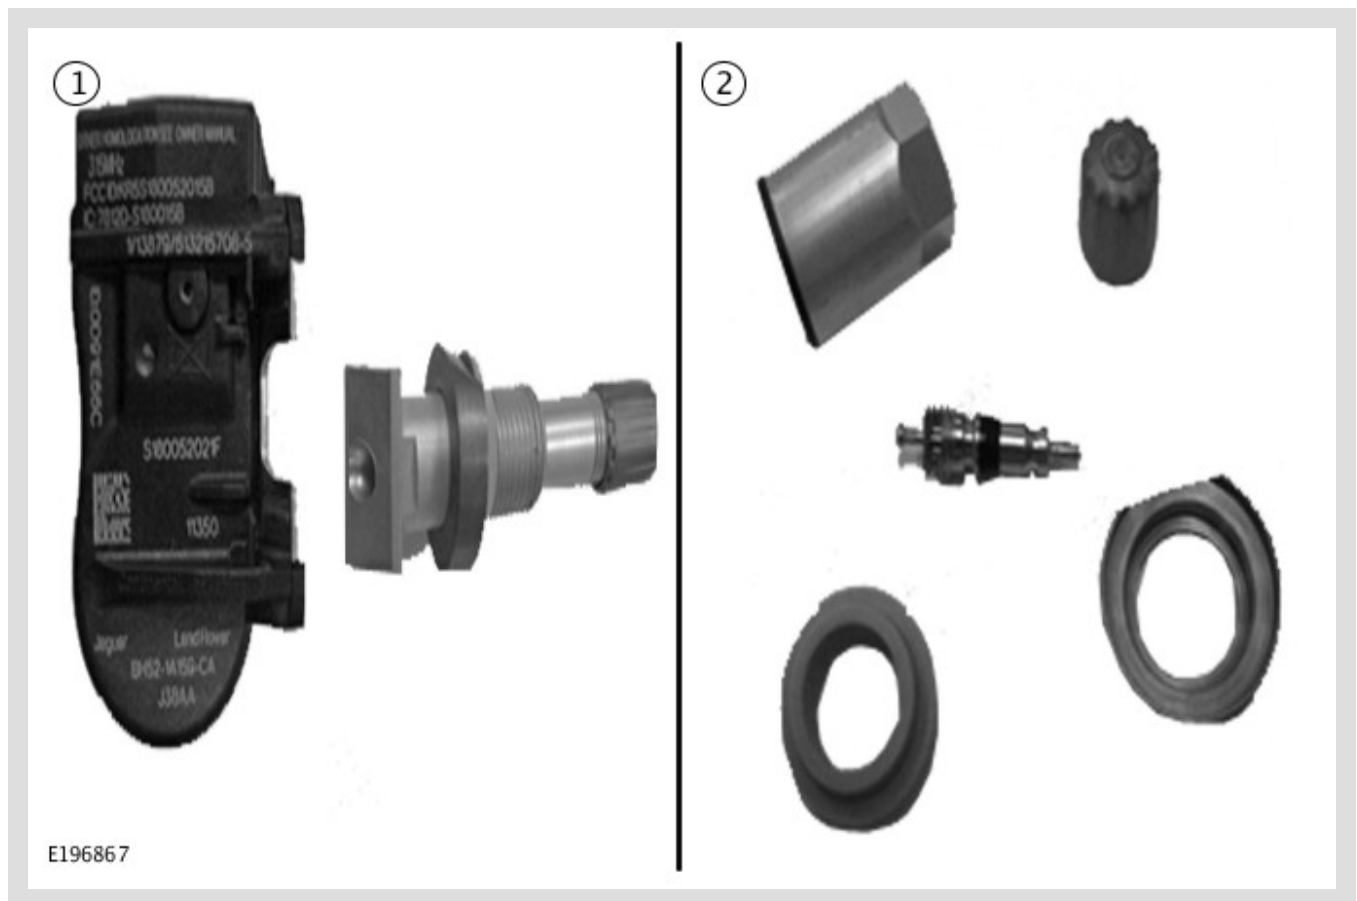
**1** TG1C Modular Valve, split in two halves mechanical and electronic modules - available as 5 piece set and as 1 piece.

**2** TG1C Valve - whole/entire valve.

Please note that Jaguar Land Rover does not cover the snapped/damaged TPMS under warranty, this is not a manufacturing defect.

If the TPMS wheel unit is a TG1C, two part TPMS wheel unit, where the valve stem can be separated use part number LR043162, valve stem kit containing 5 replacement valve stems, nuts and washers.

**UK markets only** - valve stem kit with a shorter valve stem use part number LR077043.

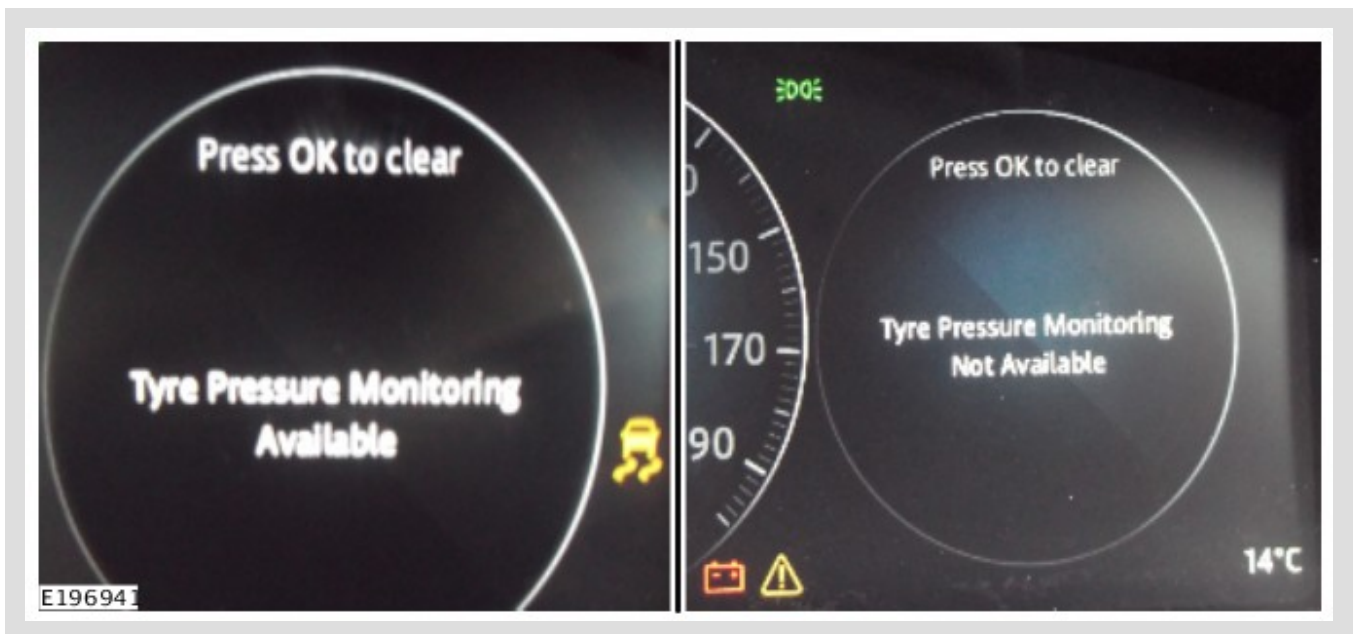
In non EU or non NAS markets, when rubber valves are fitted, the TPMS instrument cluster will display the message **"Tire monitoring not available"**, after 10 minutes of driving. The instrument cluster message **"Tire monitoring not available"**, will come on every subsequent ignition cycle, until the TPMS sensors are re-fitted.

The instrument cluster message "**Tyre Pressure Monitoring Available**", will be displayed on the instrument cluster when all four TPMS wheel sensors have been detected, and will display for 20 seconds.

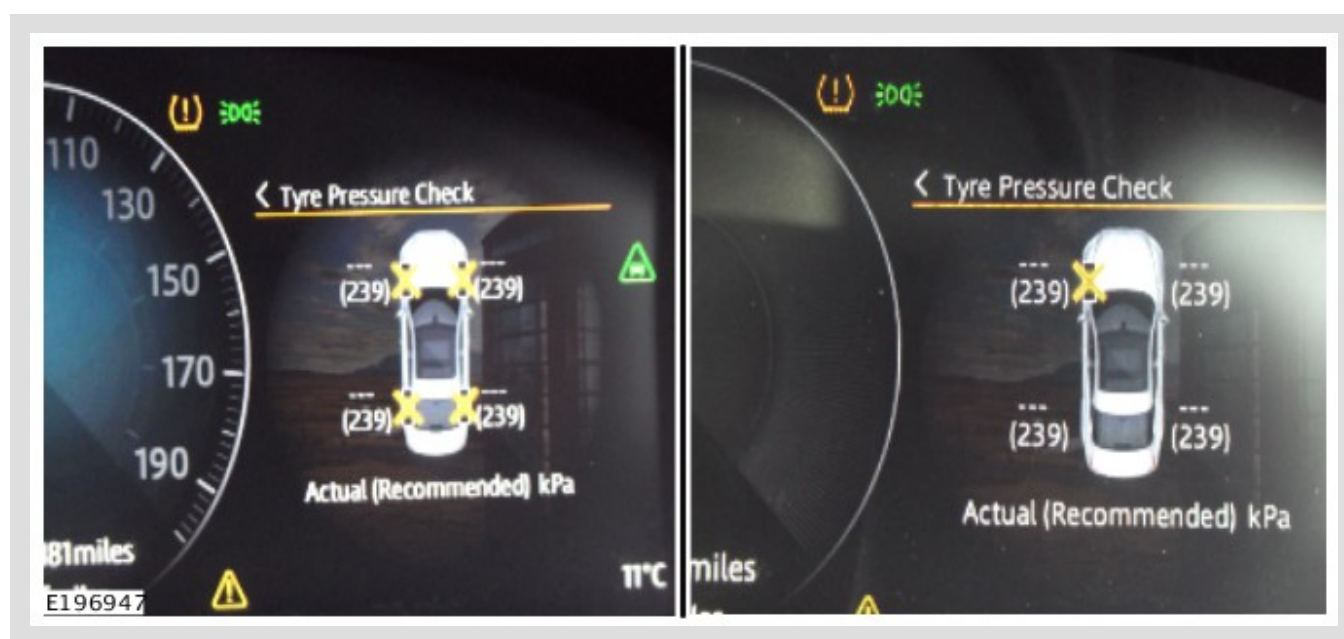
### 2.1 Wheel cannot be detected.

Using the instrument cluster menu, with the ignition on and the vehicle stationary, does the instrument cluster show one or more wheels with a yellow cross highlighted above the wheel? No then go to **section 2.2**.

Check the wheel(s) to see if a rubber valve has been fitted. If it has, replace with a TPMS valve. **Jaguar Land Rover will not pay for the warranty.**
