[Click here to print](#)
Connector: **C0994R**

Harness: **MAIN LH + RH HARNESS**

Description: **Relay-Heated front-screen**
Location: **Behind RH side of Instrument panel**
Qualifier: **RHD condition illustrated**

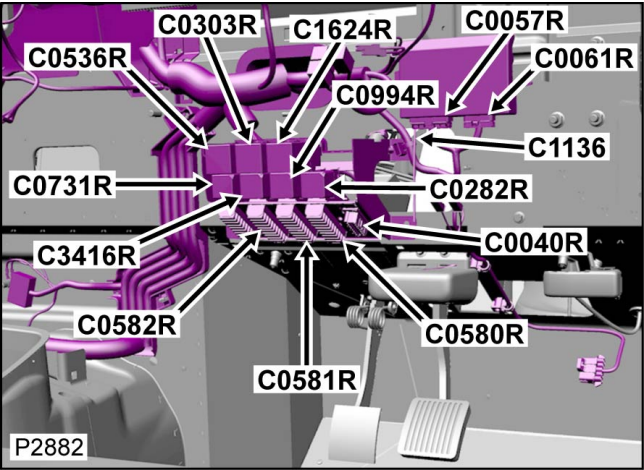
CAV	TERMINAL	CSA	COL	CCT	DESTN
30	YPLI0045	2.5D	NP	766R	C3764
85	AFU3119	0.5D	PY	109R	C1624R
86	AFU3119	0.5D	B	766R	C0289
87	YPLI0045	2.5D	PS	766R	S/JJOINT SJ42

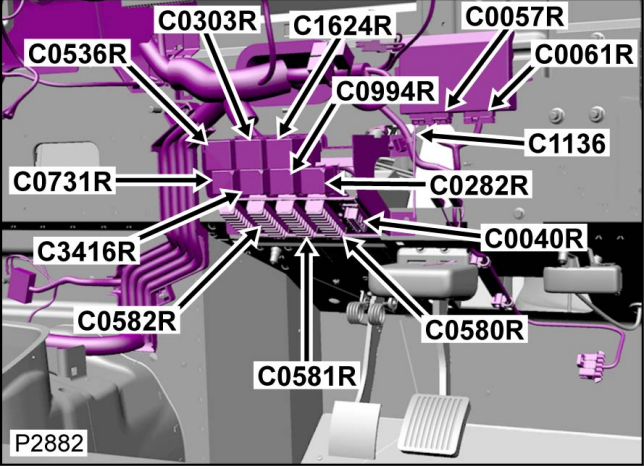
Connector: **C0994R**

Description: **Relay-Heated front-screen**
Location: **Behind RH side of Instrument panel**
Qualifier: **RHD condition illustrated**

CAV	TERMINAL	CSA	COL	CCT	DESTN
30	YPLI0045	2.5D	NP	766R	C3764
85	AFU3119	0.5D	PY	109R	C1624R
