Your problem is almost certainly failure of the 'Control Unit' on the back of the underbonnet fuse box.

It's part number - **VUB501690**

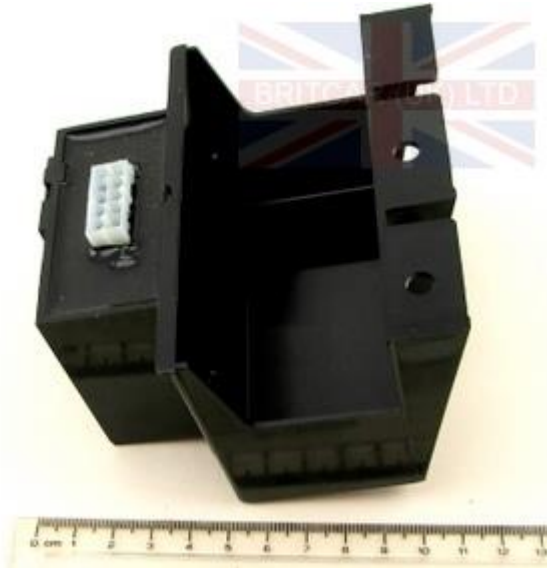
[Britcar \(UK\) Ltd > VUB501690 DRIVING LAMP CONTROL UNIT DISCO11 \(G\)](#)

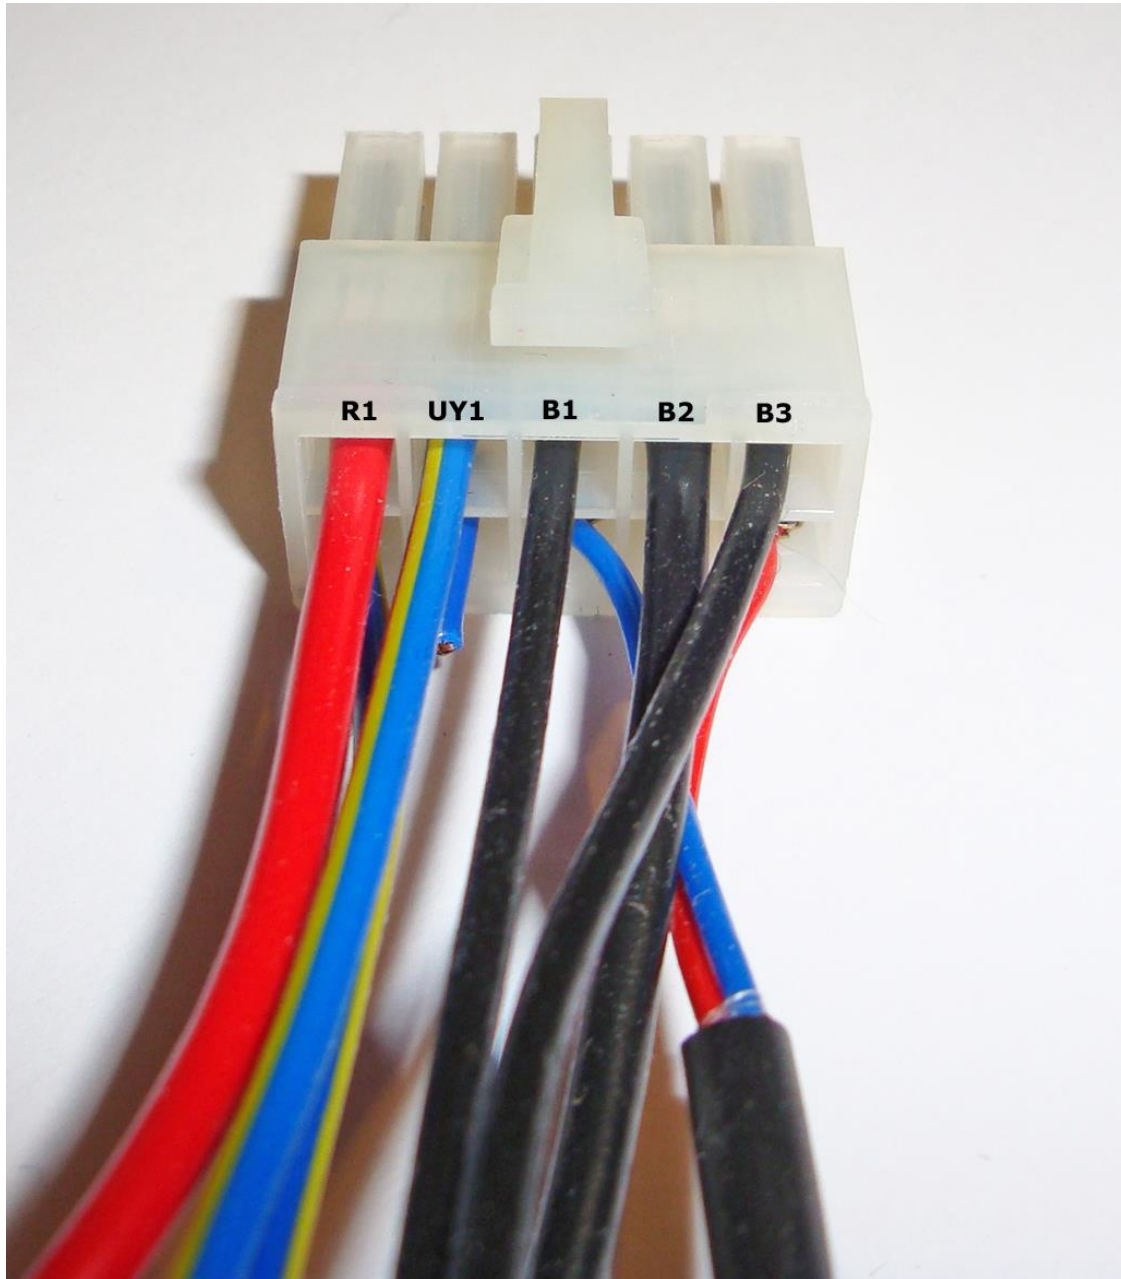
Top row -

We'll start at the 10-way connector at the 'Control Unit'

Cut **R1** - connect it to terminal 30 of your relay

Cut **B2** - connect it to terminal 85 of your relay

Cut **UY1** - we'll deal with this wire soon...

Cut **B1** and **B3** - crimp them together in an M6 eyelet and take them to the earth

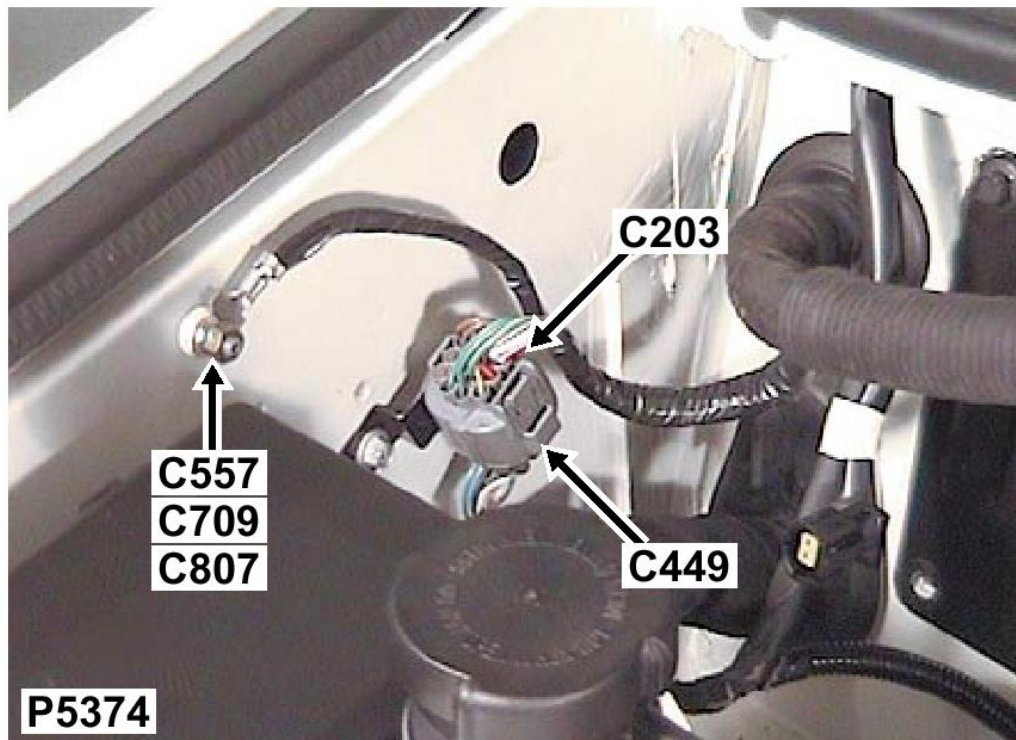
point **C0557/C0709/C0807** on the inner wing -

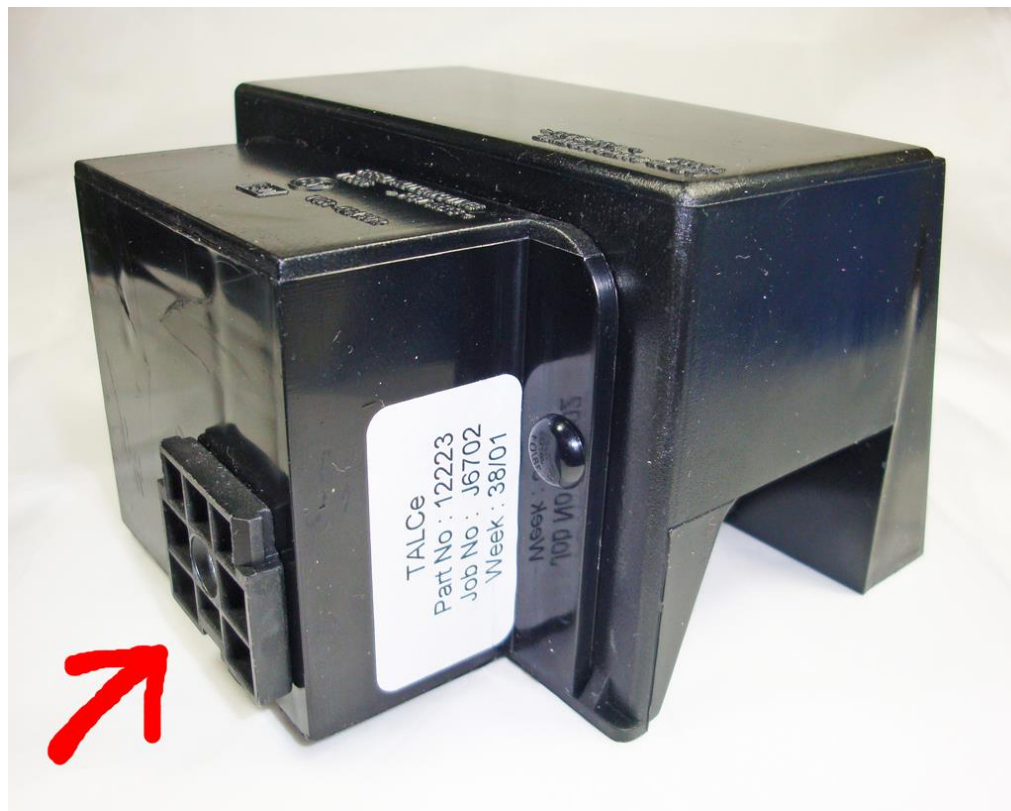
The mounting bracket that the fuse holder clips to, can be removed from the 'Control Unit' body and mounted elsewhere.

It's held on by a small countersunk screw.

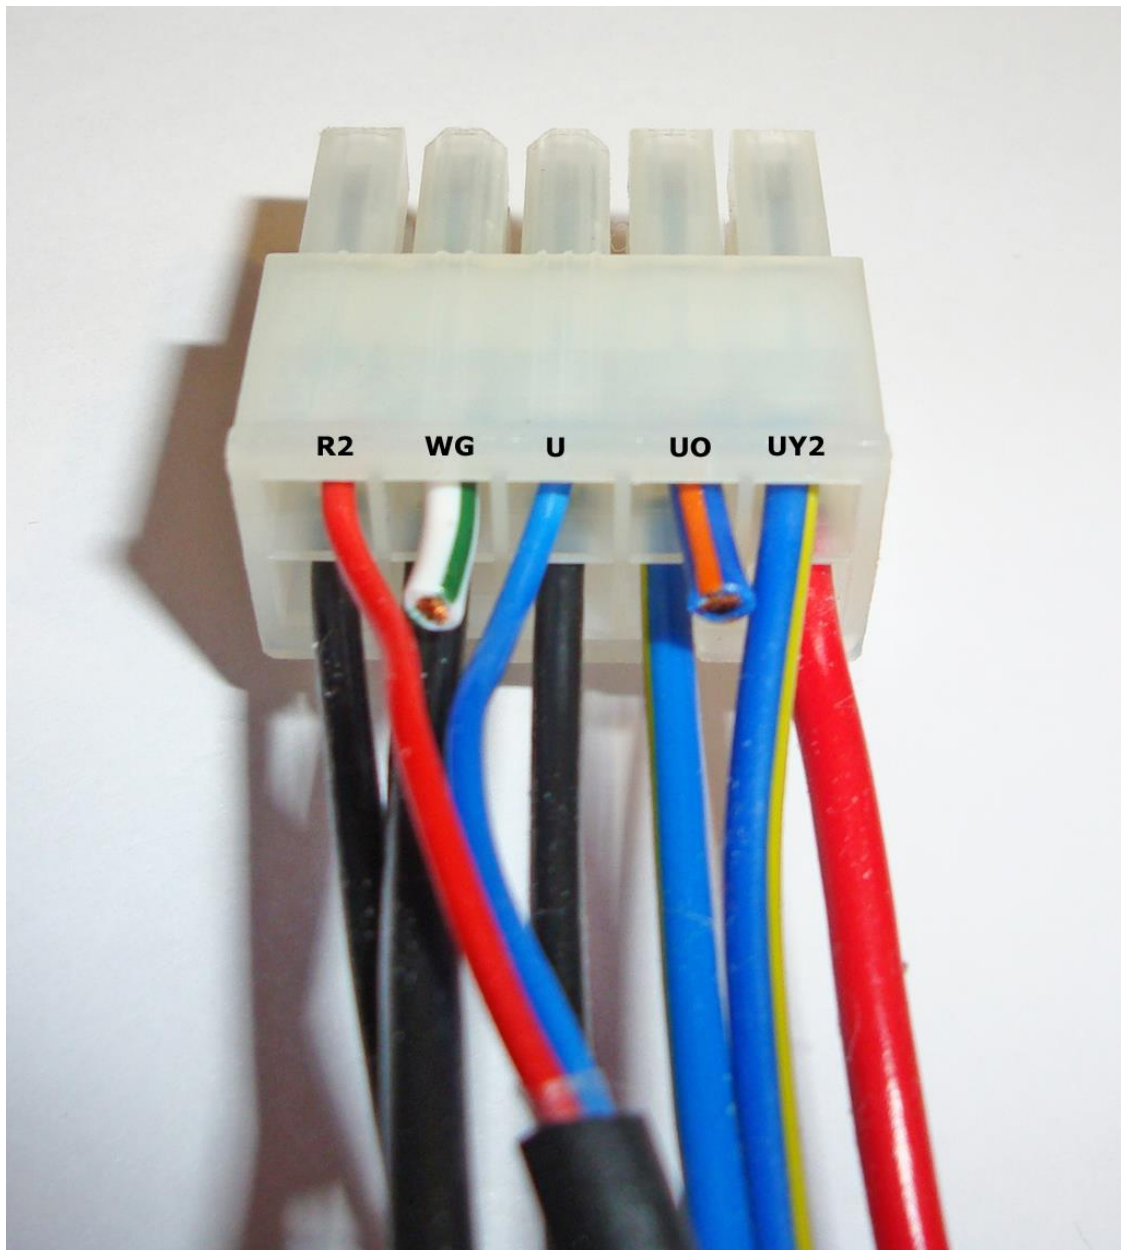
Bottom Row -

(ignore the fact that I've already cut the White/Green and Blue/Orange wires)

Cut **R2** and **UO** - join them together (solder and sleeve, or splice joint)

Cut **U** - connect it to terminal 86 of your relay

Cut **UY2** - connect it, with **UY1** from the top row, to terminal 87 of your relay

Cut **WG** - NOT NEEDED - remove it back to it's 'tap-off' under the engine compartment fusebox, in a 'reverse' of the installation procedure, below -

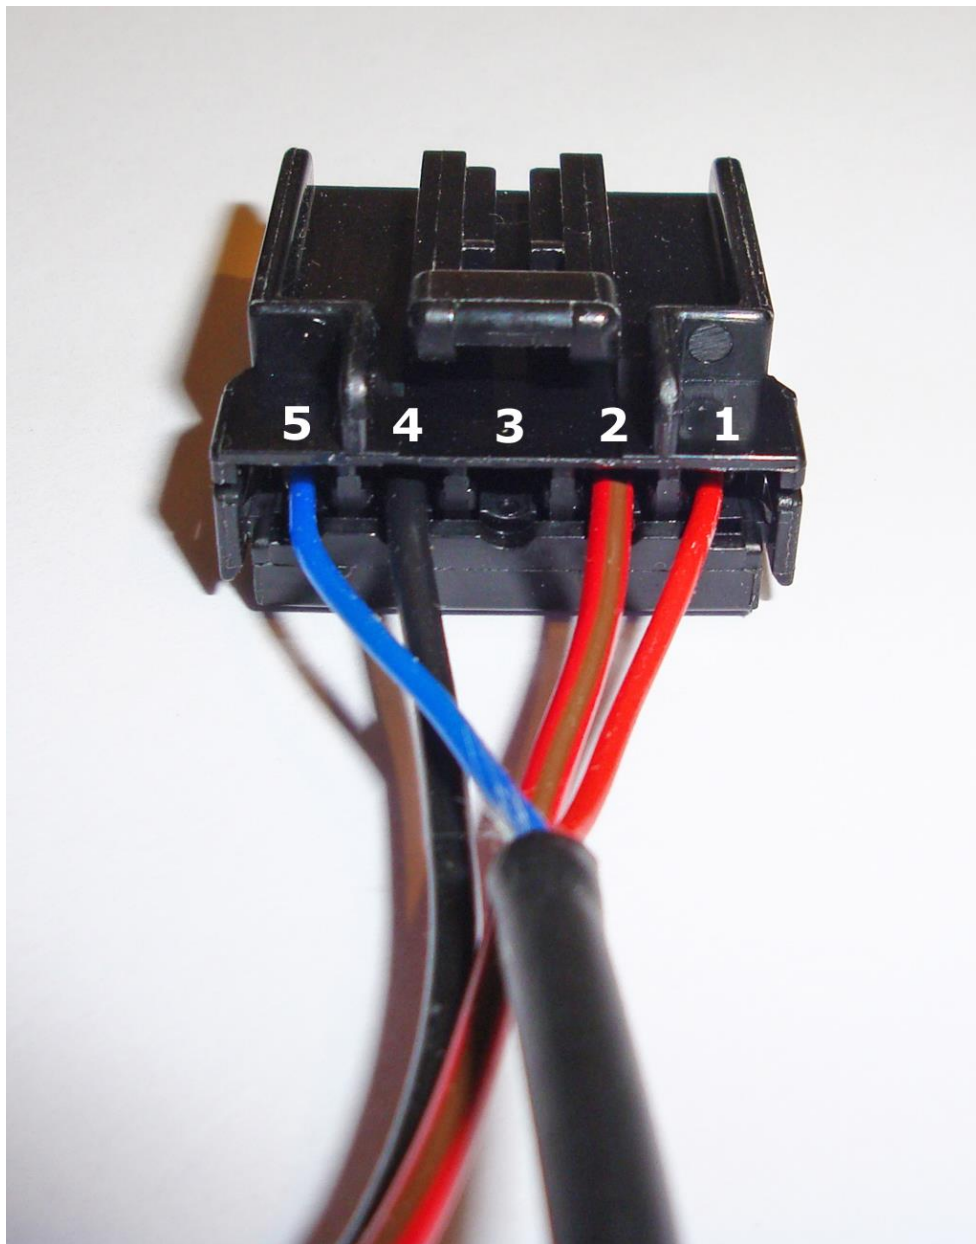
At the Black switch connector –

Open the hinged terminal lock and, using a safety pin from the front of the connector -

Release the Blue wire from cavity 5 and the Black wire from cavity 4

Swap their positions, so that the Blue wire is now in cavity 4 and the Black wire is now in Cavity 5

Close hinged terminal lock

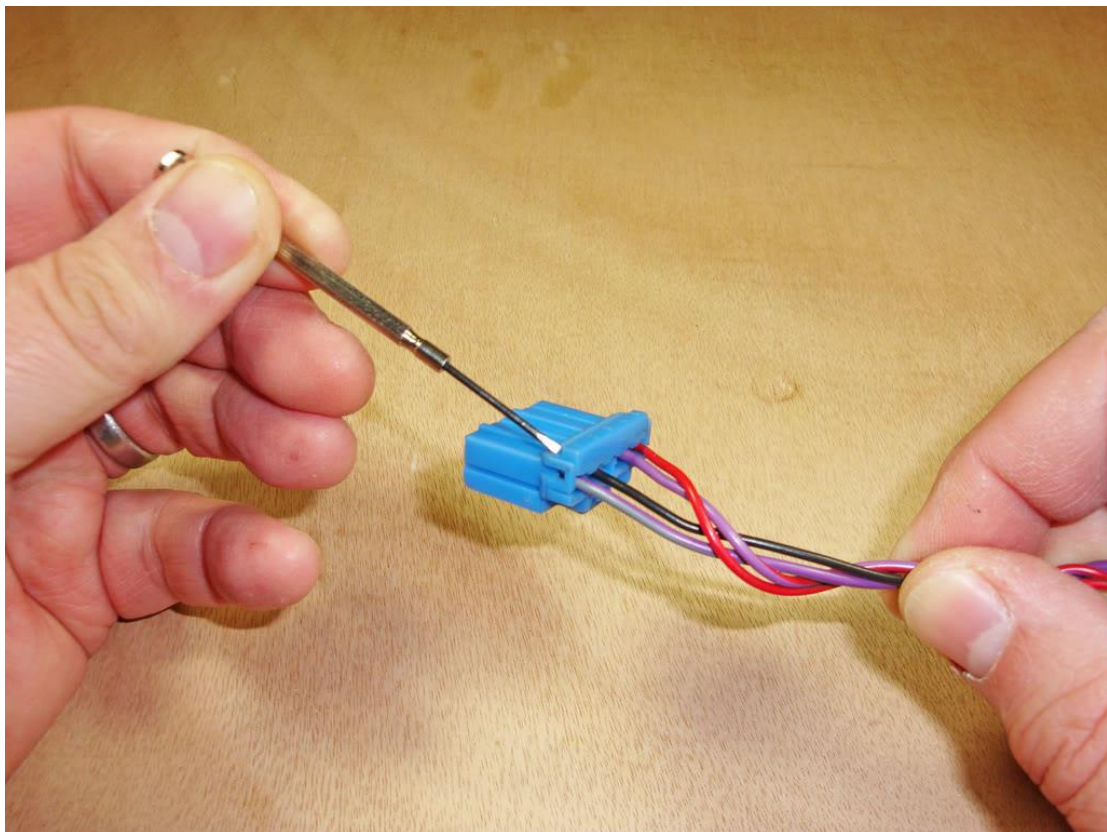
Use a small screwdriver to open the hinged terminal lock, 1st side -

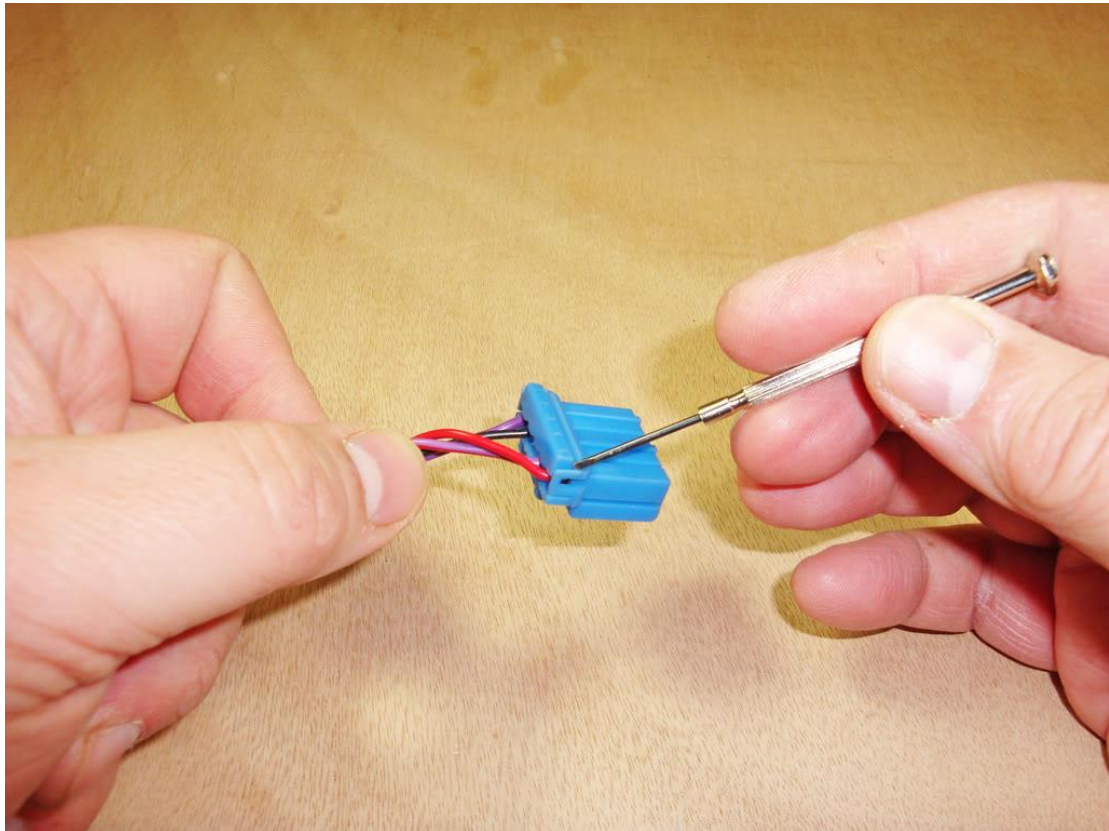
And on the 2nd side -

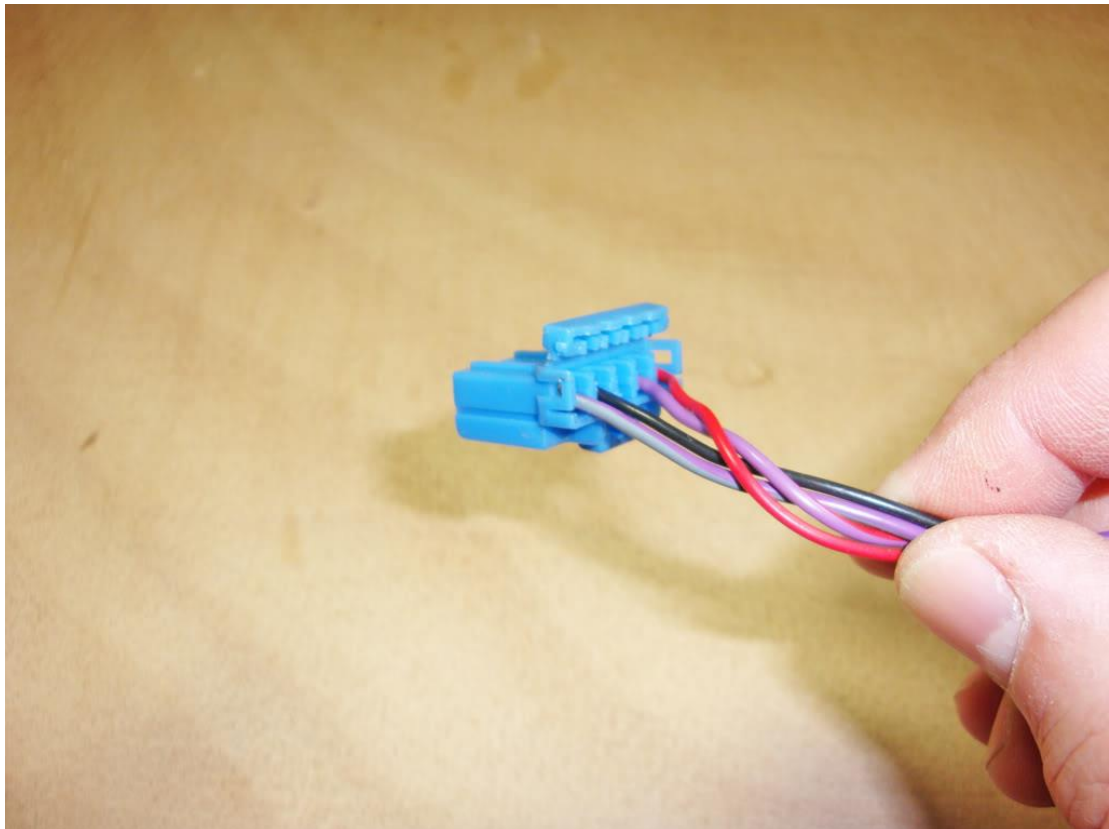
Hinged terminal lock opened -

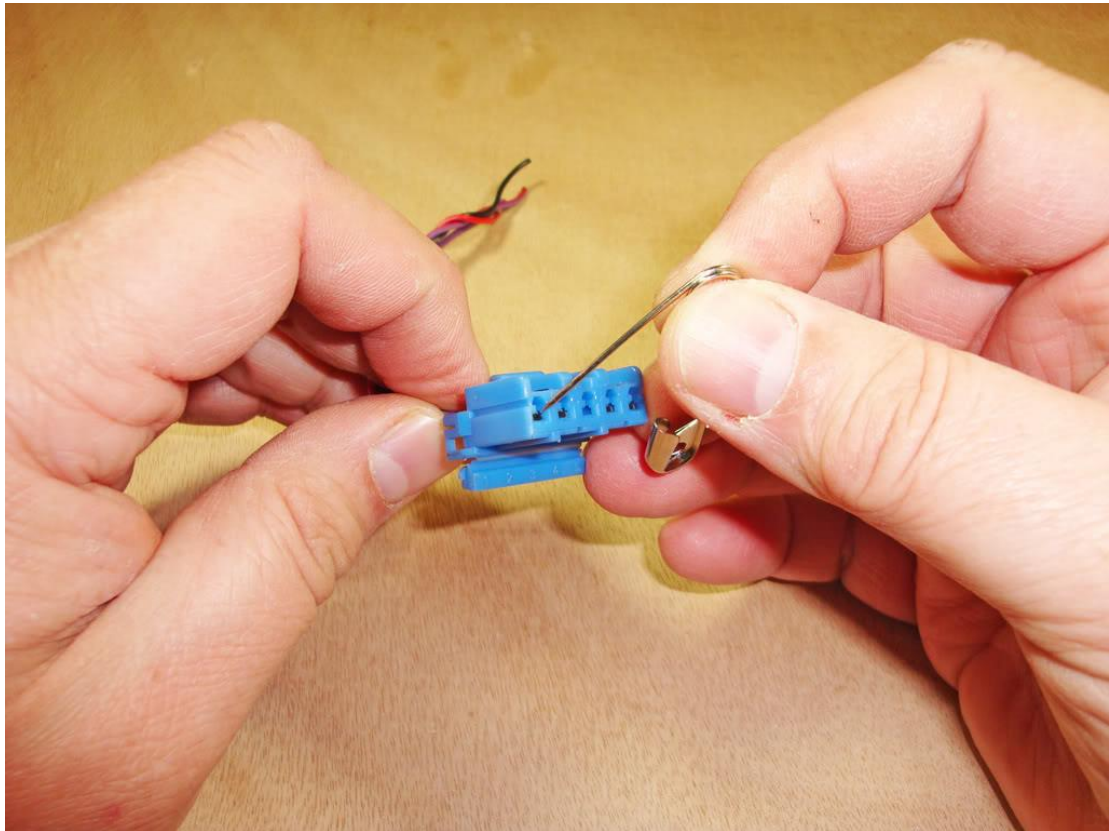
Use a safety pin to lift the locking tab above the wire's terminal -

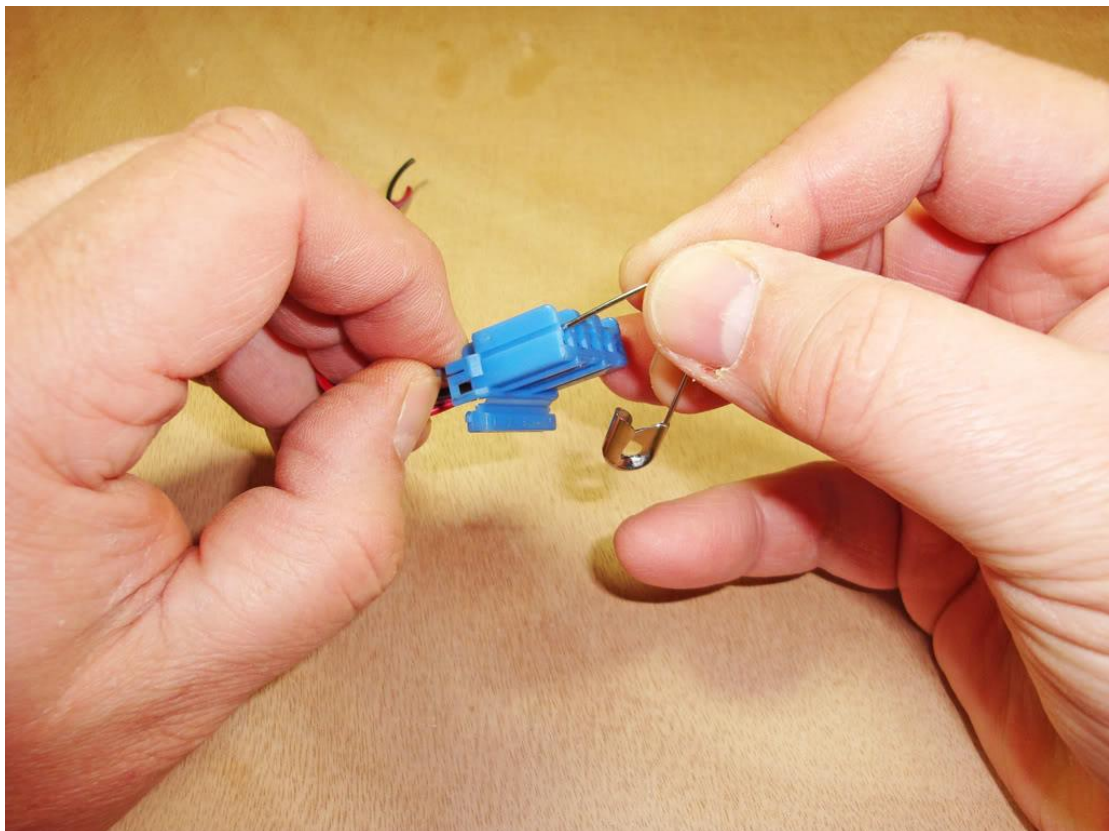
At the same time as lifting the locking tab, pull gently on the wire

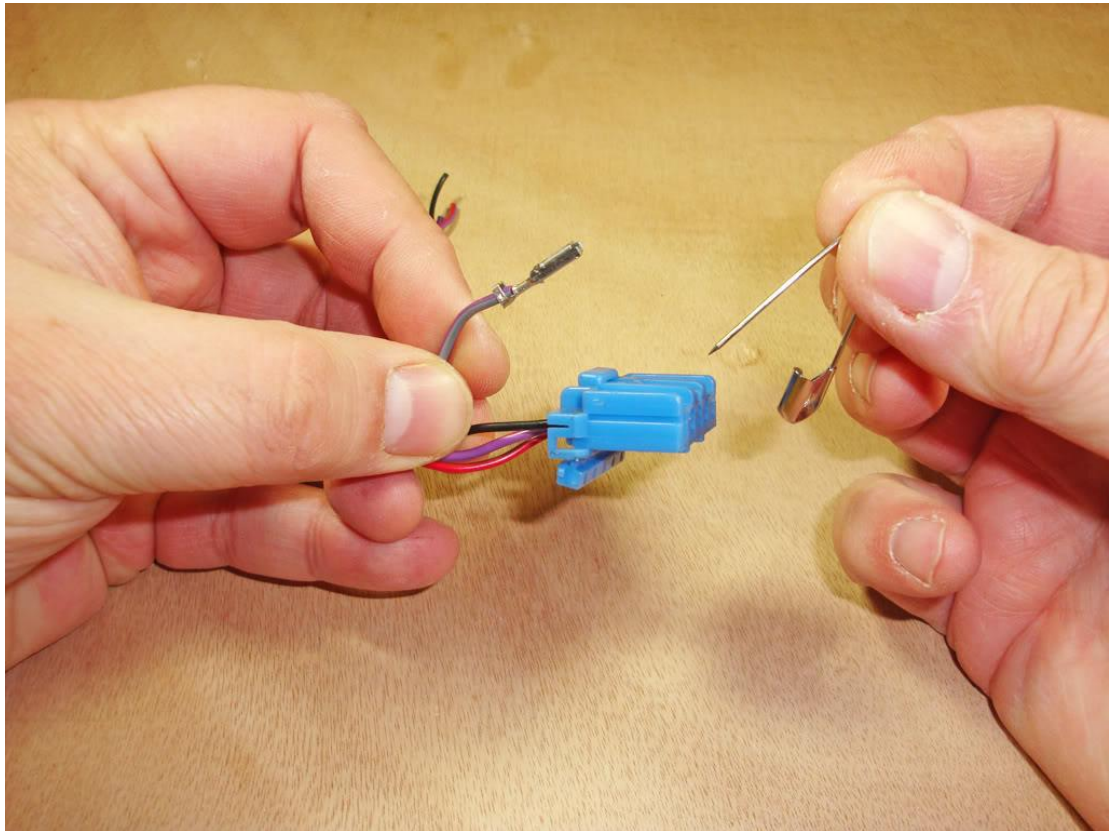
Terminal released from connector housing -
