**Purpose of the study:** Motor vehicle set disadvantages LAND ROVER

**Objectives of the study:** determine the cause of motor vehicle disadvantages LAND ROVER DISCOVERY 4, VIN

### Discovery 4 engine failure

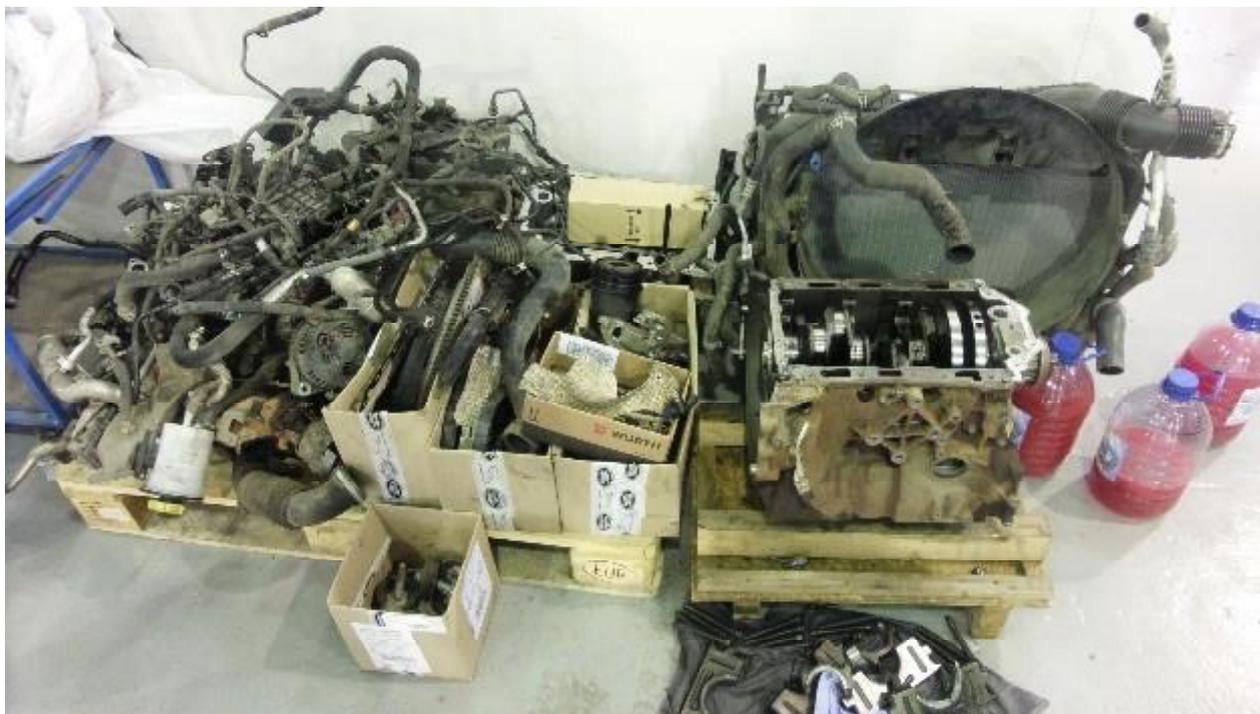
Fig. № 5. dismantled and disassembled engine attachments of the test vehicle

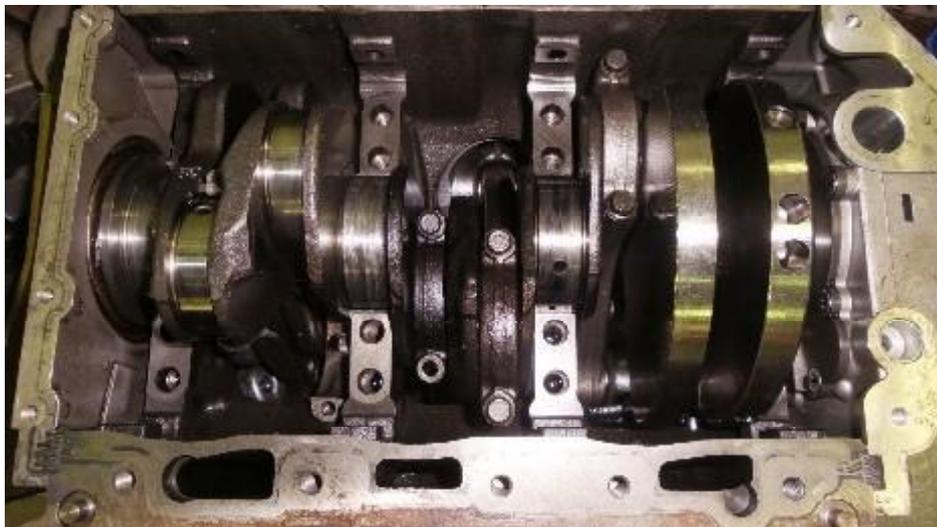
Inspection of the engine revealed his shot partial disassembly, namely - Disassembling the timing, by performing the removal of the oil pan, crankshaft and pistons of the four cylinders were not removed and are located inside the cylinder block of Fig. №6.

Inspection and study of the bottom of the engine Fig. №6 revealed the following:

- on all four cylinders are present cooling nozzles;
- connecting rods and pistons have no breakage indication, all the pistons in the cylinders can be easily moved without shimming;
- engine block clean without traces of oil fumes.
- inspection of fusion antifreeze and oil indicates that they are correct and working condition. The presence of impurities is not revealed. The color and smell correspond to the working properties of process fluids. Mixing the oil and coolant is not set - the emulsion is absent.
- inspection of the oil filter revealed the presence of small chips in the filter element, indicating the presence in oil of small metal inclusions formed as a result of the wear process - mechanical friction.

Fig. № 6. disassembled, with removal of the pallet, the test car engine LAND ROVER DISCOVERY 4

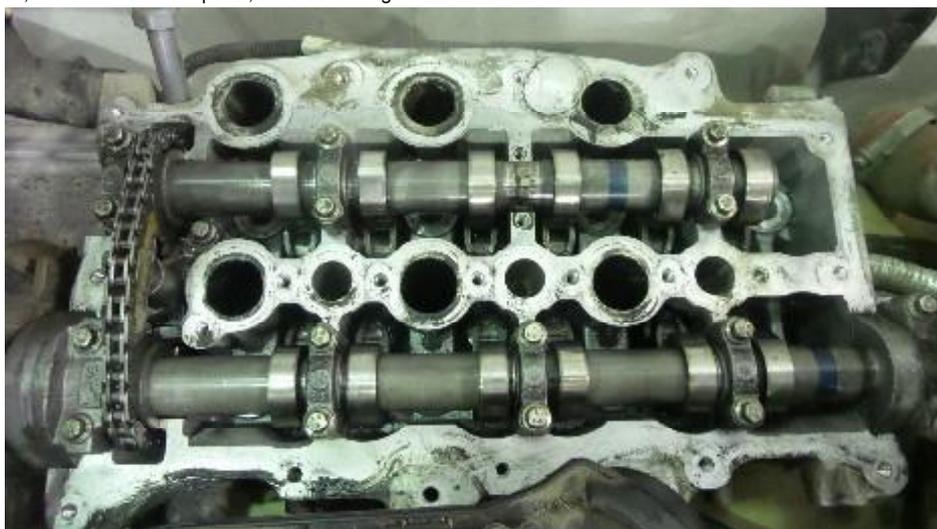
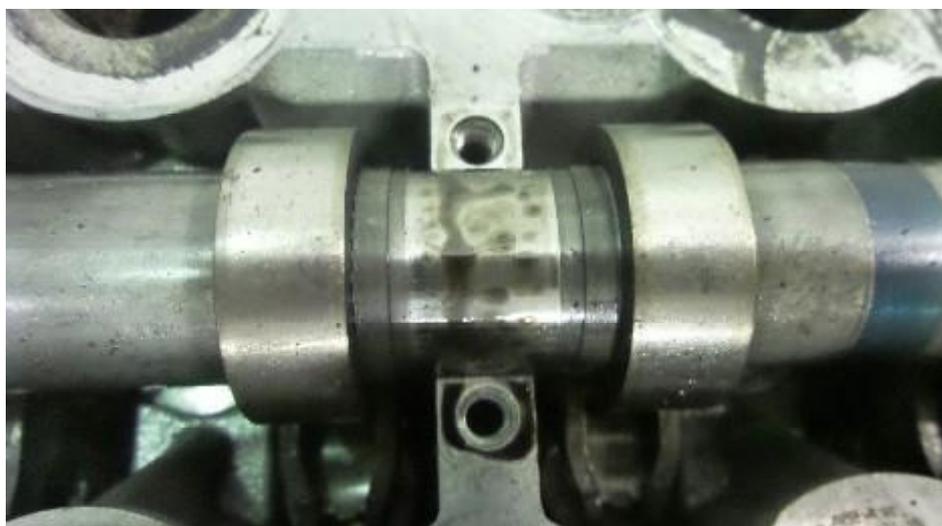
Fig. № 7. The cylinder head (one of two) of the motor vehicle investigated LAND ROVER at removing covers a cylinder head (Fig. №7) installed camshafts are properly installed and are in perfect condition, excessive friction traces in the form of scuffing and signs of overheating in the form annealing do not have. Valve mechanism without a trace faults. Condition Cylinder head gasket without gusts and traces of leaks.

The absence of traces of oil starvation in the cylinder head indicates the operating state of the oil pump, since the disruption in the form of a pressure drop in the oil system leads primarily to oil starvation in the most remote points, and that the plane of cam sliding in the cylinder head, and as indicated above camshafts are properly installed and are in perfect condition, excessive friction traces in the form of scuffing and signs of overheating as a discolouration has not.

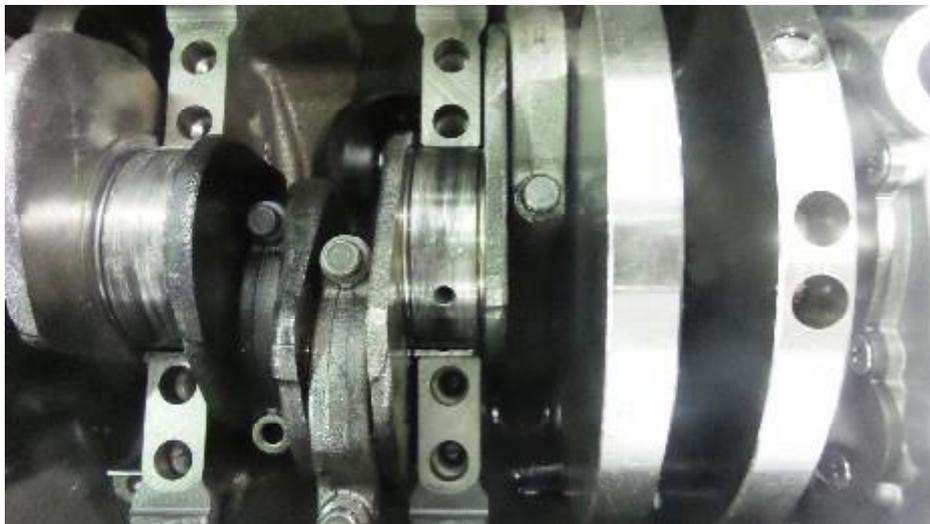
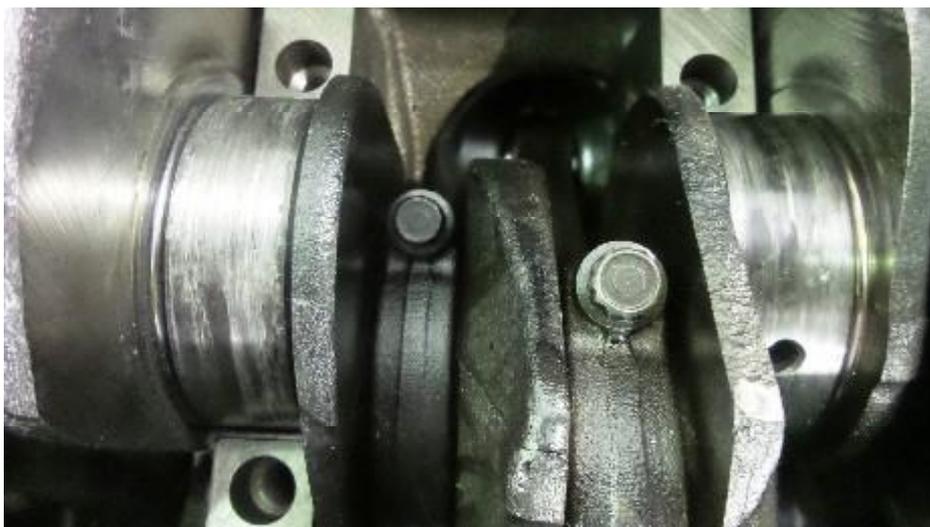
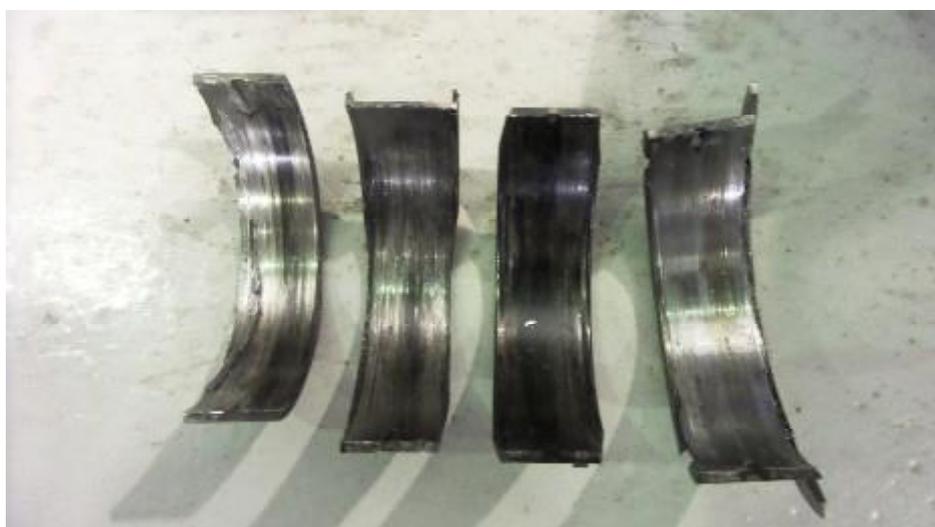
Fig. № 8. Native neck engine inserts the test vehicle LAND ROVER DISCOVERY 4, VIN  
decapping main journals of the crankshaft and inspection of their indigenous inserts revealed traces of  
increased friction in the form of burrs and deformations with  
partial destruction of the inserts Fig. №8;

- decapping main journals of the crankshaft and inspection of their indigenous inserts revealed traces of increased friction in the form of burrs and deformations with the partial destruction of the inserts;

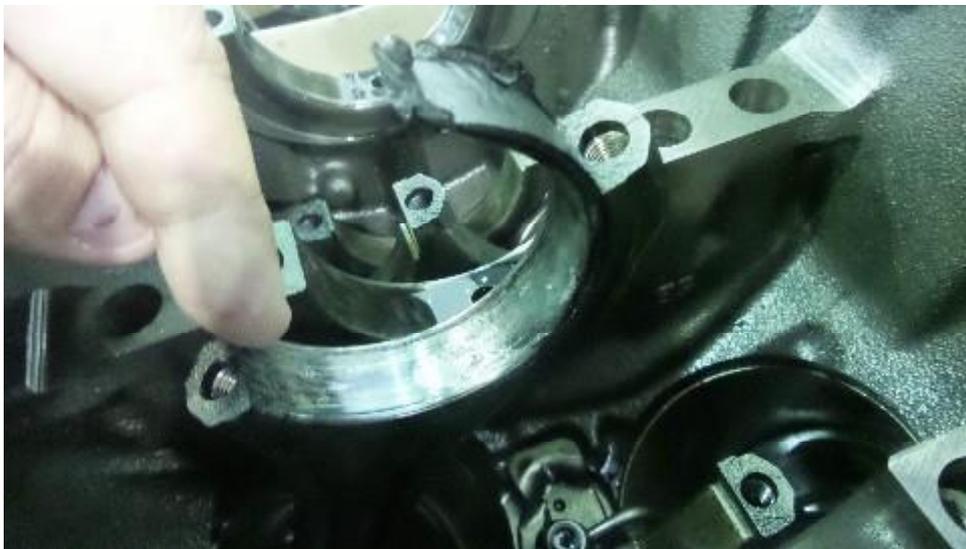
Fig. № 9. The connecting rod is welded by friction liner motor vehicle investigated LAND

inspection rod liners also revealed traces of increased friction and wear in the form of burrs and deformations. Identified as well as traces of overheating annealing and welding by friction of a connecting rod

inserts Fig. №9.

- inspection rod liners also revealed traces of slip cylinders 5 and 2 in the form of burrs and deformations. Identified as well as traces of overheating annealing and welding by friction liner rod of the second cylinder.

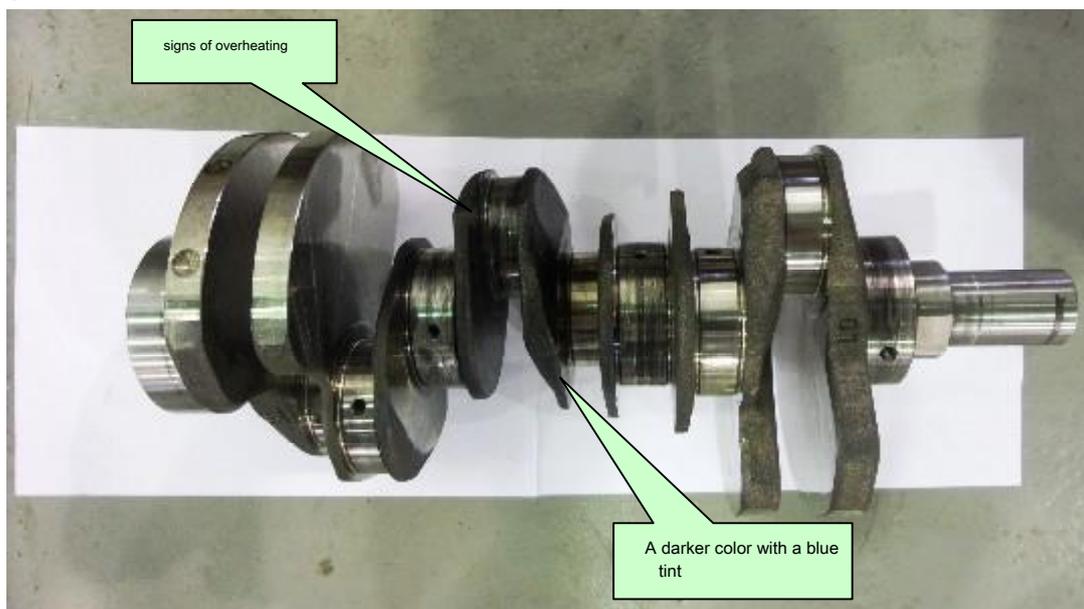
Fig. № 10. Visual inspection of the test vehicle engine crankshaft LAND ROVER DISCOVERY 4, VIN

Removing and thorough inspection of the crankshaft in the presence of faults and fractures of the crankshaft results has not given. Crankshaft visual whole.

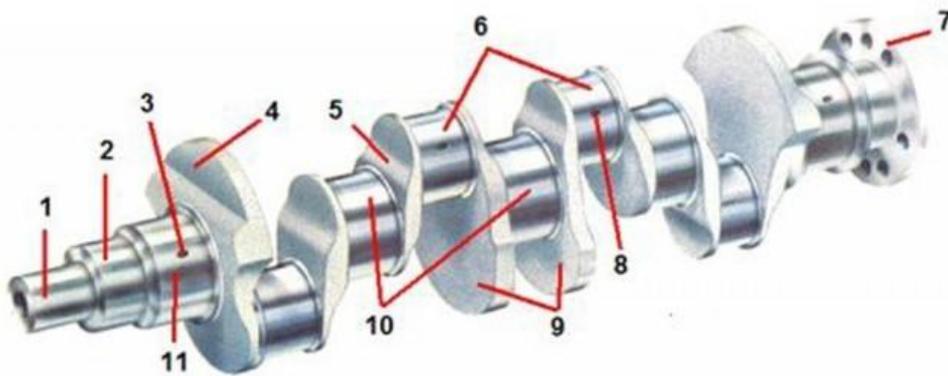
Crankshaft (Fig №11.) - is part of an internal combustion engine which converts the reciprocating motion of the pistons into torque. Apparatus crankshaft include cheeks, crankpins and counterweights, a shank flange. The support of the crankshaft - the root of the neck. In the test six-cylinder engine crankshaft with four pillars. The crankshaft must be durable, have low weight, balanced, have a precise processing. On the crankshaft during operation to bending and twisting forces. That there was no premature failure pair

Fig. № 11. Driving the internal combustion engine crankshaft device.

1. Sock of the crankshaft;
2. The seat sprockets (gears) driving the camshaft;
3. The oil feed hole to radical neck;
4. Counterweight;
5. Cheek;
6. Crankpin;
7. The flange of the flywheel;
8. The oil feed hole to the crankpin;
9. counterweights;
10. Main journals;
- eleven. Radical neck thrust bearing.

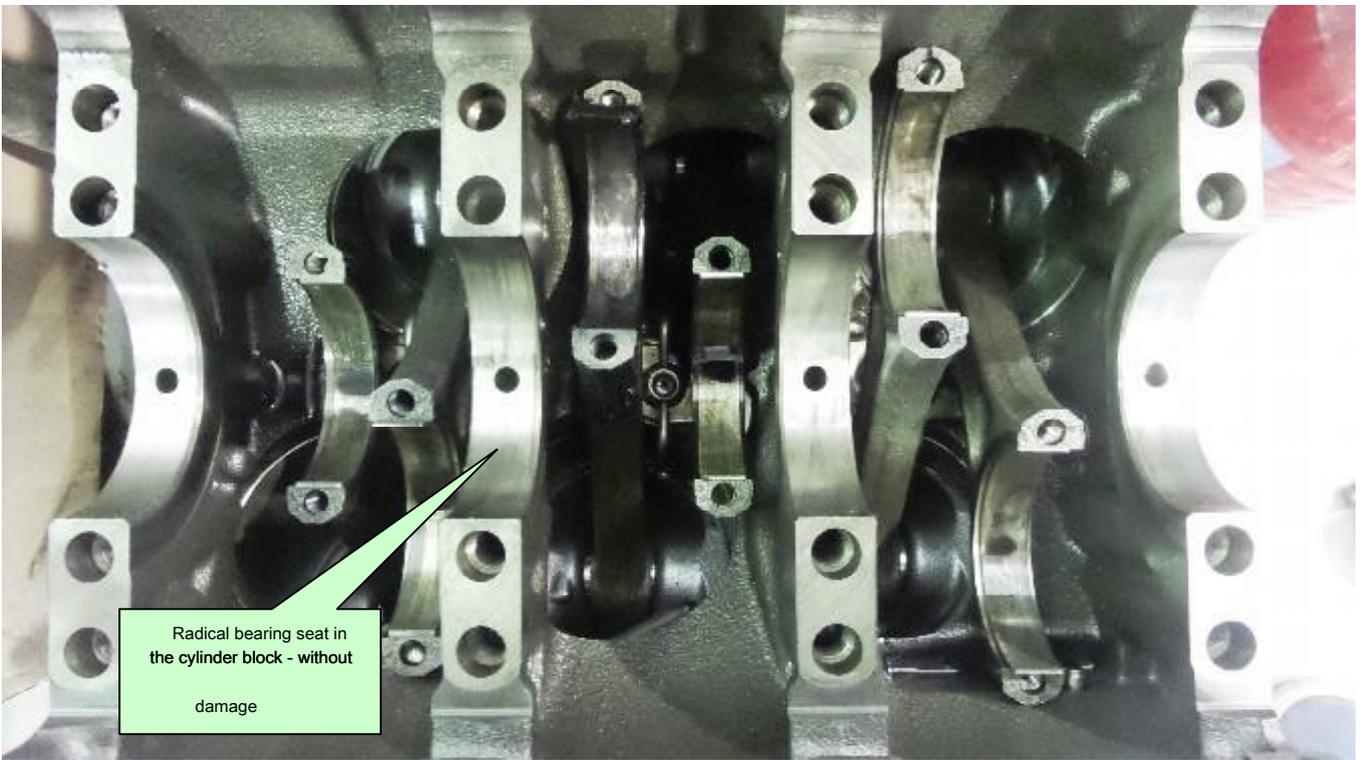
Fig. Number 12. Status of indigenous necks after removing the crankshaft of the test engine car LAND ROVER

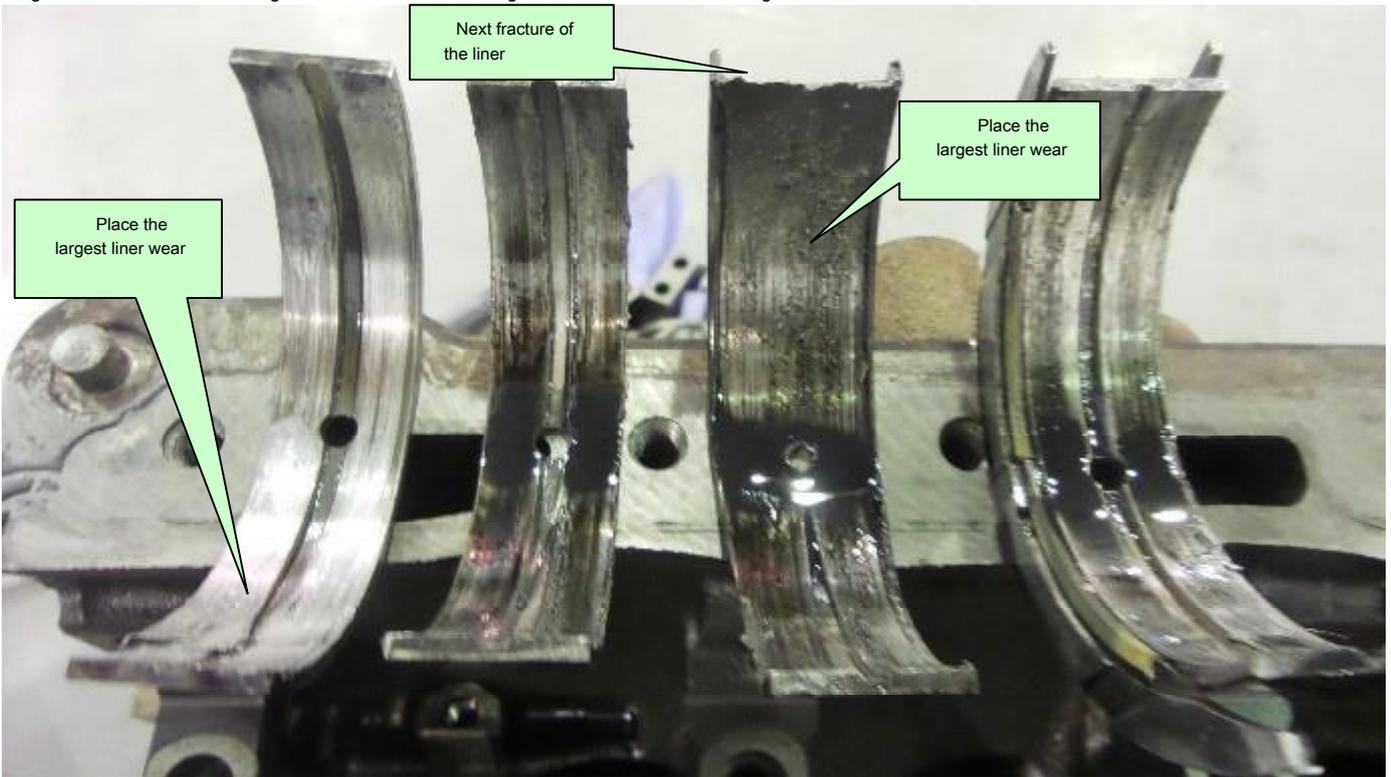
Indigenous damaged liners all (Fig №13,14.) - being worn their inner part and the outer, which is adjacent to the block and closures of wear and scuffing does not except the liner third crank journal. Insert a third crank journal (which is attached to the cylinder block) has a strong wear of the inner surface and the part where the locking is completely split off Fig. №15. There is a deformation (flattening) of indigenous inserts Fig. №14,15 in consequence of shock. Cranking, in consequence of fracture of the insert part (split off the part where the liner disposed locking), led to a shift of the insert and partial overlapping oil supplying channel to the crankpin of the second cylinder Fig. №15, lowering oil pressure and as a result the oil starvation insert rod Fig. №15. The result of oil starvation crank liner was welded it to the connecting rod Fig. №9 and engine seizure. The cheeks of the crankshaft in the region of 2 and 5 cylinders are dark blue hue Fig. №10, indicating that they overheat due to friction.

Fig. № 13. Condition root bushings after removal of the test vehicle the crankshaft of the engine LAND

- radical loose all damaged - and worn their inner part and the outer, which is adjacent to the block and closures of wear and scuffing does not except the liner third crank journal. Insert a third crank journal (which is attached to the cylinder block) has a strong wear of the inner surface and the part where the locking is completely split off. There is a deformation (flattening) radical loose leaves in consequence of shock loads. In consequence of the destruction of part of the insert (split off the part where the liner disposed locking) resulted in a shift of the insert and partial overlapping oil supplying channel to the crankpin of the second cylinder, lowering oil pressure and as a consequence oil starvation rod insert. The result of oil starvation crank liner was welded it to the connecting rod and engine seizure.

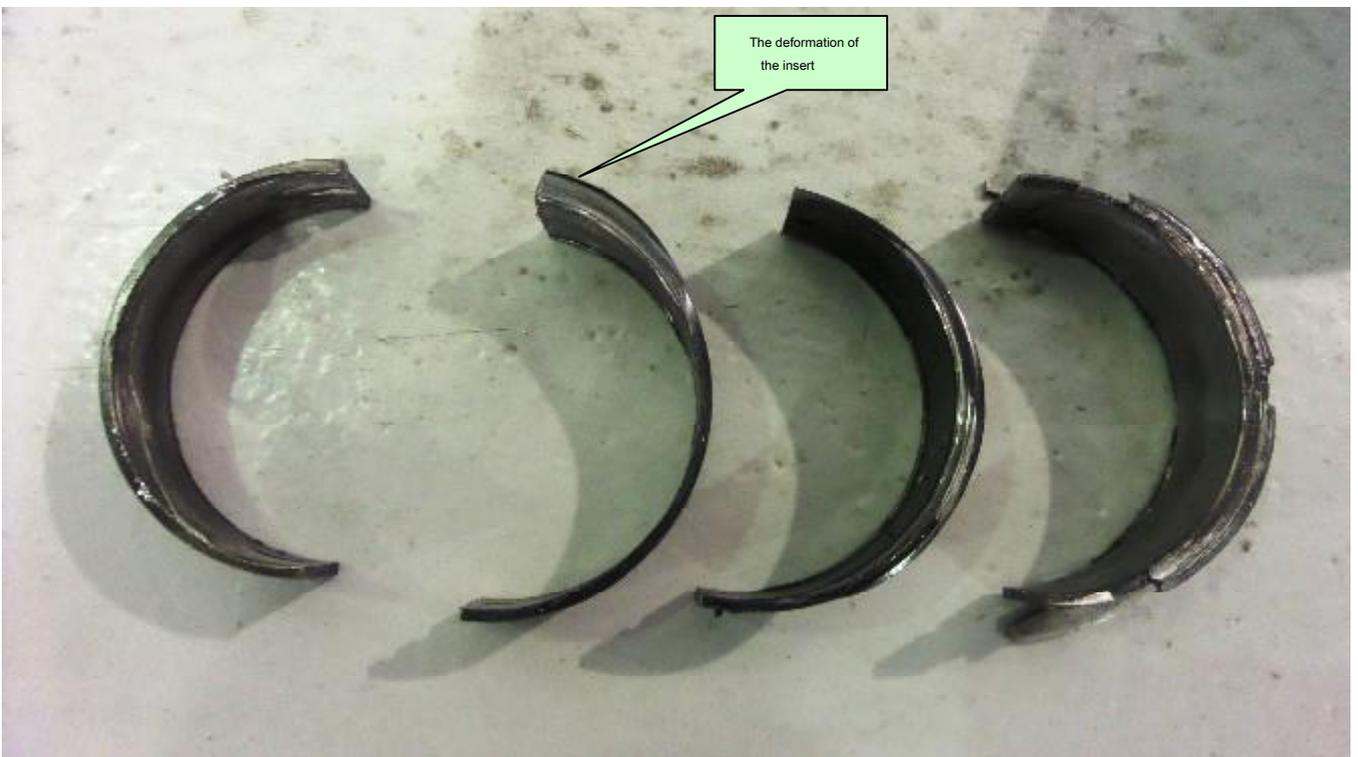
Fig. Number 14. Status of indigenous inserts after removing the crankshaft of the engine of the test vehicle LAND ROVER DISCOVERY 4,

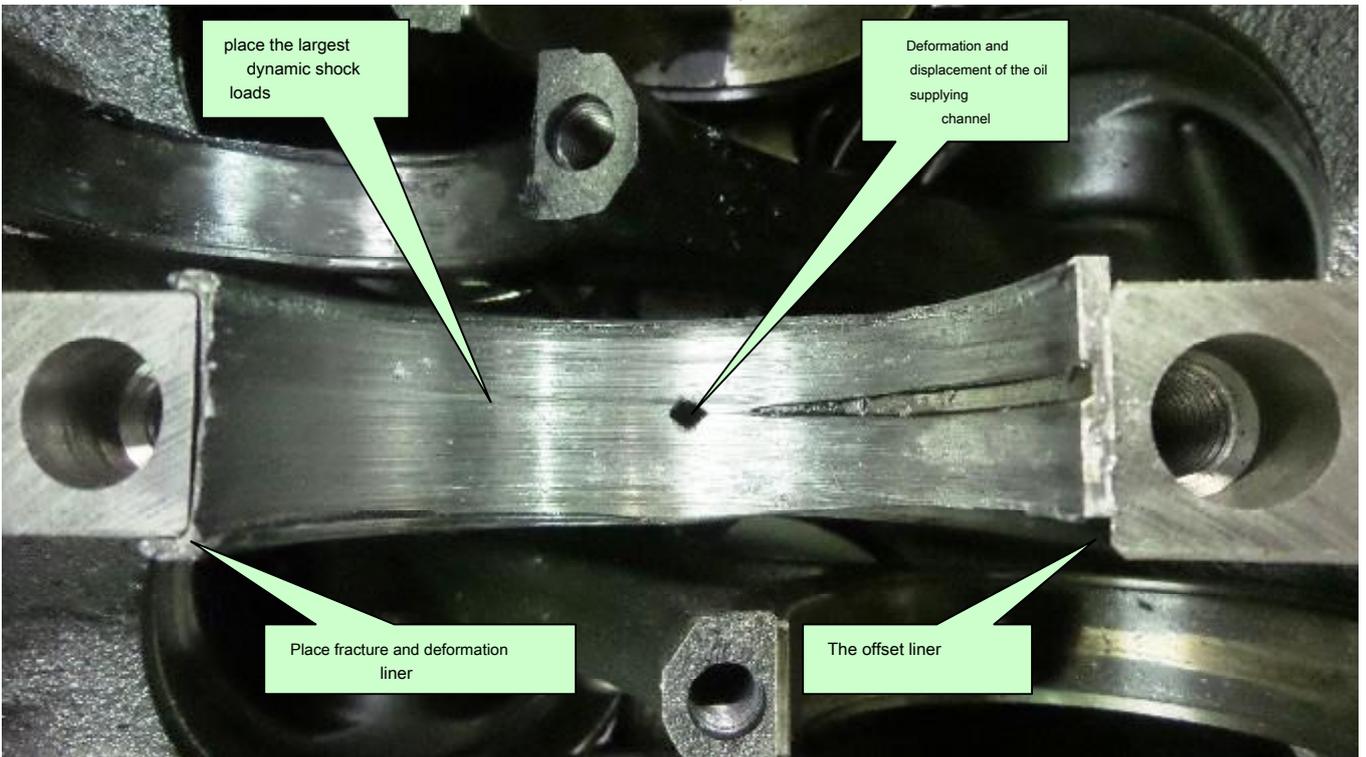
Fig. № 15. Root insert after removal of the test vehicle the crankshaft of the engine LAND ROVER
