TD5 ALIVE - EGR BYPASS KIT

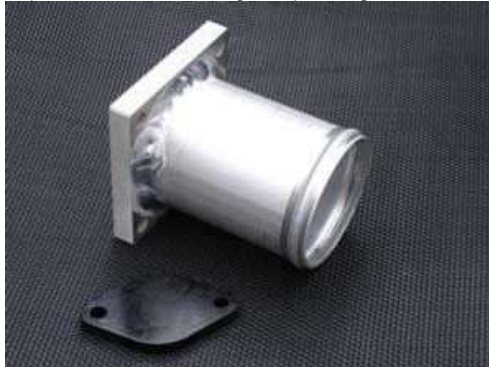
The TD5 Alive EGR bypass kit is a direct replacement for the original EGR valve, and bolts neatly between the intercooler outlet and inlet manifold. The EGR valve body replacement is made from high quality, laser cut aluminium, with a rolled edge for secure fixing of the intercooler hose. The exhaust manifold blanking plate is made from 6mm thick mild steel, so will not distort under high exhaust temperatures. Both items are made from the same materials as original parts, so will give a perfect fit under all engine operating conditions.

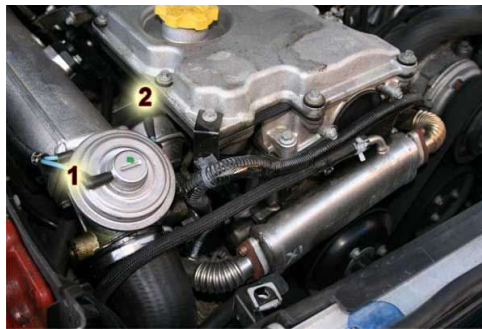
NOTE: There are two types of Td5 EGR system, Early EU2 type, as fitted to 1998-2001 models, and Later EU3 type (pictured below) fitted to 2001-2007 models. Note two vac pipes to two actuators (1 & 2), and the EGR heat exchanger.

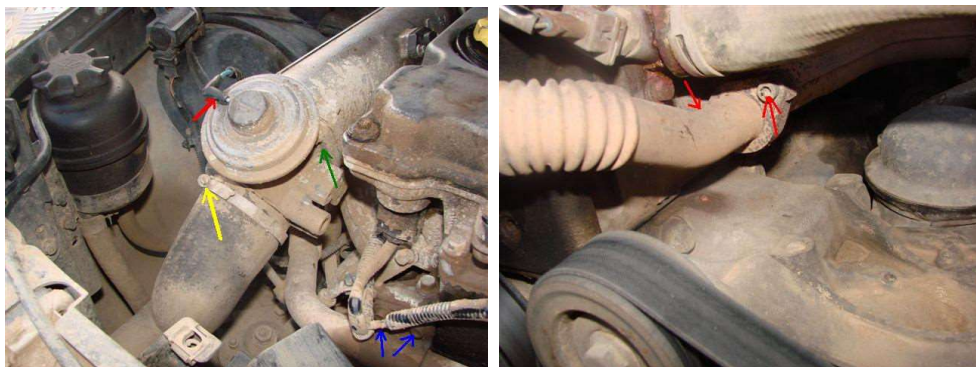
Disconnect the vacuum hose(s) from the EGR valve, red arrow in photograph, then blank it/them off (a small self tapping screw is ideal), and finally tie up out of the way. A good idea is to ty-rap the vac hose(s) to the new EGR body.

Remove the 4 x 8mm bolts, one of which is marked by the green arrow, holding the EGR valve to the inlet manifold.

Remove the 2 x 8mm bolts, marked in blue, from the EGR re-circ pipe, where it fastens to the front of the cylinder head. (EU2 models only)

Loosen the jubilee clip, marked by yellow arrow, and release the engine air intake hose from the EGR valve.

Remove 2 x 5mm Allen bolts securing the EGR valve re-circ pipe to exhaust manifold. These are marked by red arrow in photo 2.

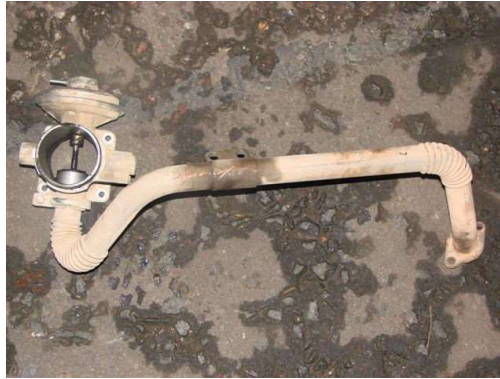
The EGR assembly can now be removed as a complete assembly (early EU2 type shown Below). EU3 assemblies will be in two parts, due to the inline heat exchanger.

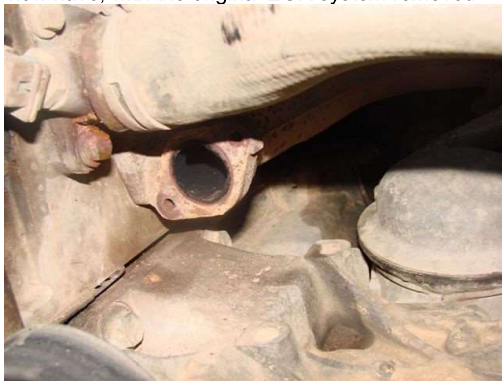
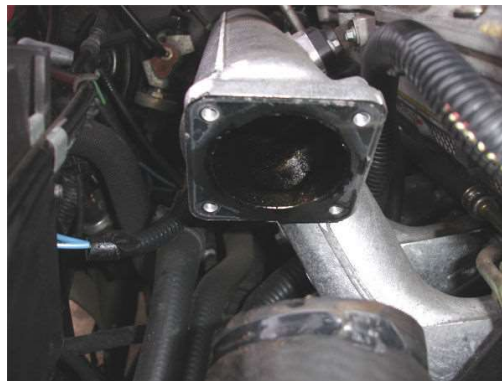
This is what you will now have, with the original EGR system removed.

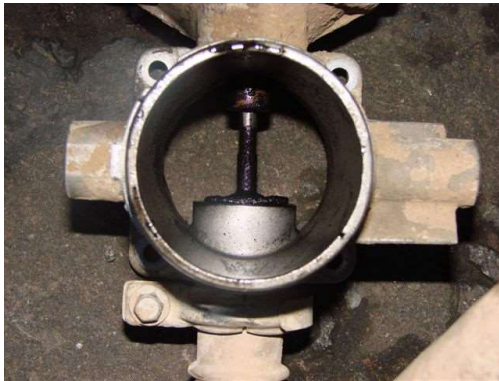
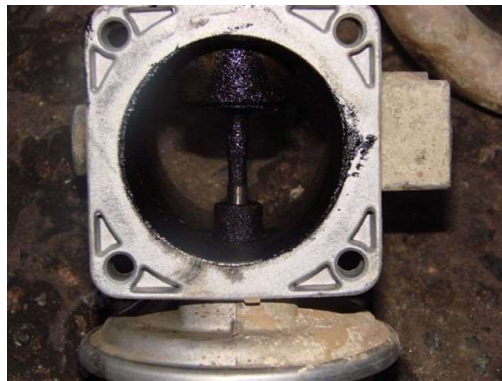
Looking at the photographs below, the restriction caused by the original valve can be seen clearly. Also notice the residual sludge build up left by the dirty exhaust gases!

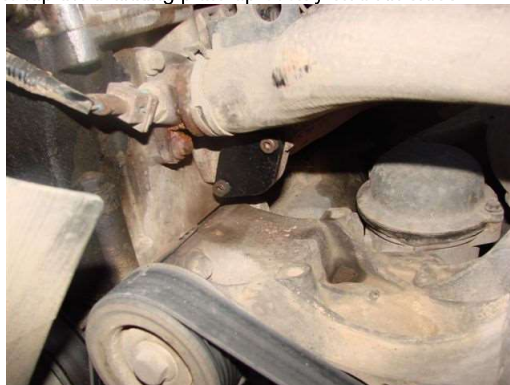
The exhaust blanking plate is simply attached to the exhaust manifold with the 2 Allen bolts. No gaskets are required for this, as both are machined flat surfaces, and will seal well. Just take care to nip the blanking plate up evenly on both sides.

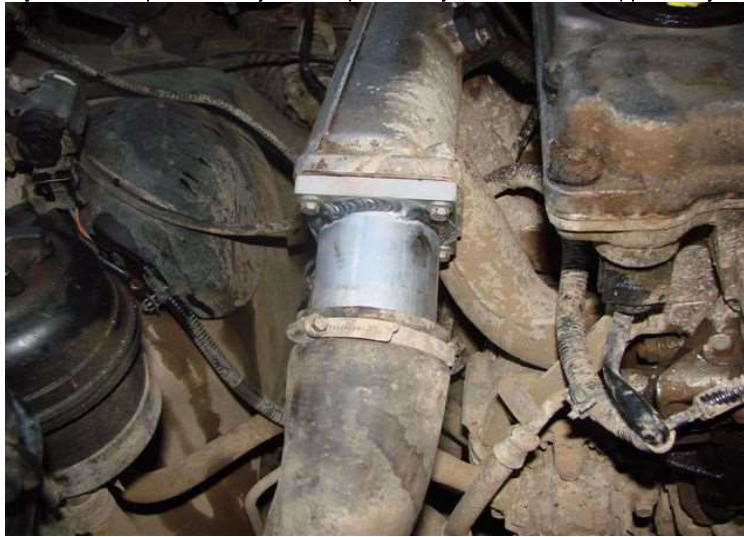
The new EGR Body is bolted to the intake manifold with the 4 bolts. **Prior to fitting**, please ensure that the pipe is clean, and free from any metal fragments left from manufacturing, and the mating face of the inlet manifold is clean. Use the new gasket (supplied) to seal the joint. The intercooler air hose can then be reconnected and the jubilee clip tightened. Refit the engine cover. Note that sometimes these jubilee clips can fail, and so will need to be replaced. Please ensure you have a spare 80mm jubilee clip to hand just in case this happens to you!

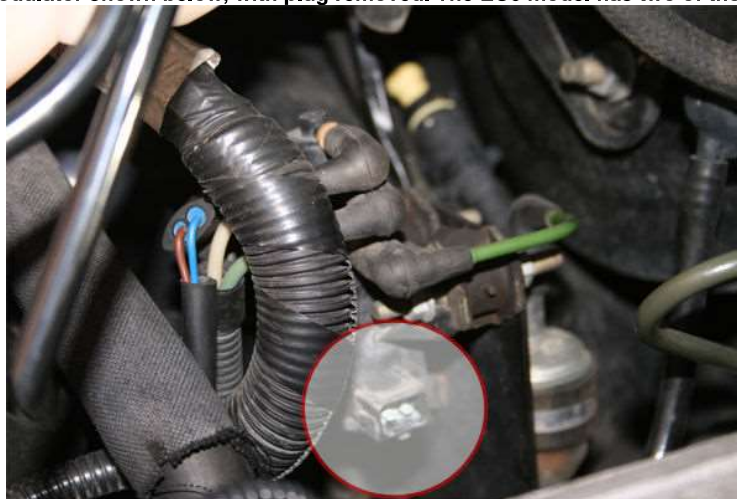
Discovery, early (EU2) model modulator shown below, with plug removed. The EU3 model has two of these, so disconnect both plugs.

It is recommended that you disconnect the electrical connector(s) from the EGR modulator(s), to prevent vacuum from being applied to the now redundant vac hose(s). The engine management will then sense there is no EGR system fitted, so will disable any attempts of EGR operation. The modulator(s) are located on the right hand inner wing. Early models have just one, and later (EU3) models have two. Unplug the **electrical connectors only** from the modulators. **Leave all vac pipes in situ, attached to the modulators and brake servo pipe!** This is for your safety, as the brake assistance could be severely compromised by incorrect or inadequate fittings.

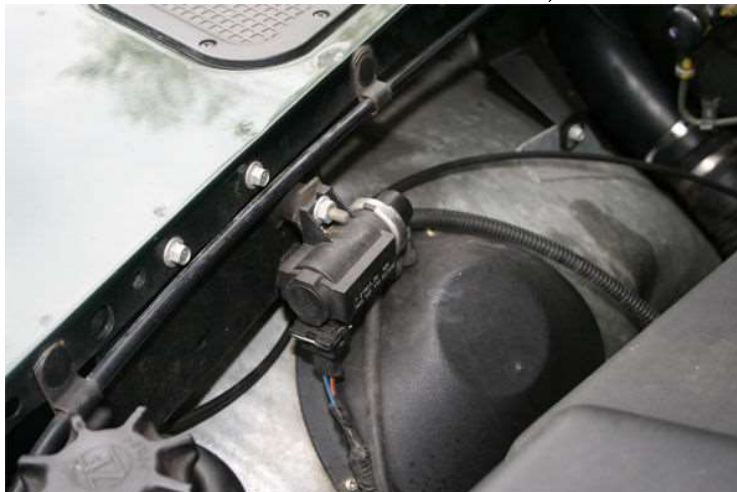
Defender early (EU2) model modulator shown below. The EU3 model has two of these, so disconnect both plugs.

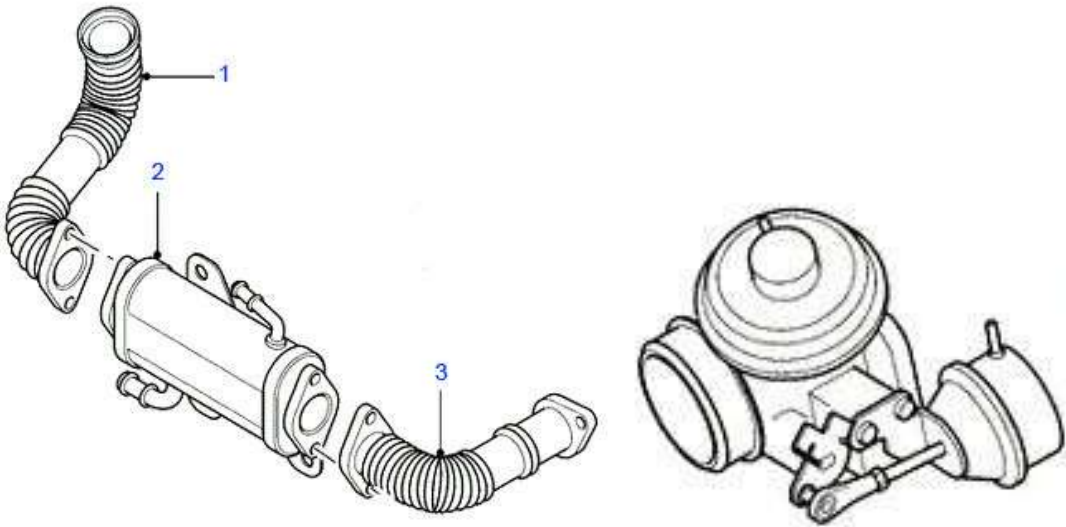
If you have an EU3 engine (Post 2001 models), then your EGR re-circ pipe will most likely have a heat exchanger fitted, as in the picture below. The only exception to this is with very late TD5 Discovery models, and Rest of World spec vehicles.

If you have this type, then you should remove pipes **1** and **3**, leaving the heat exchanger (**2**) in place. Use the additional 2 blanks to seal this. See how the later type EGR valve body (above) has an additional actuator on it's side. The vac pipe to this will need to be removed and blanked off as well as the vac pipe to the top actuator. I recommend using self tapping screws for this, as they will seal the pipes, and won't fall out. Fasten these pipes to the new EGR body, with a ty-rap.

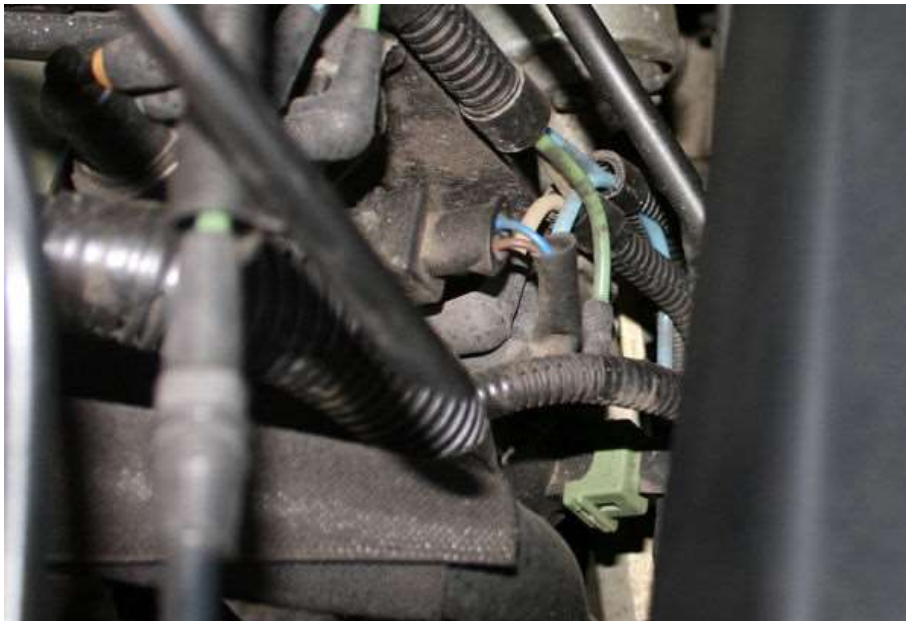
This EU3 EGR system has two electronic modulators, which should both be disconnected electrically. Black, and Green plugs (pictured below)
