# Land Rover Defender Discovery TD5 Diesel 2.5 Starter Motor Repair Kit Install

## **Intro:** Land Rover Defender Discovery TD5 Diesel 2.5 Starter Motor Repair Kit Install

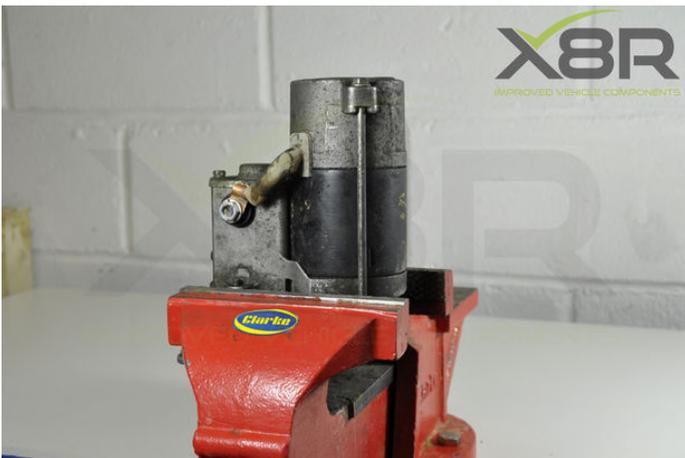
To be certain of compatibility part numbers can be found on a silver sticker on the starter motor body.

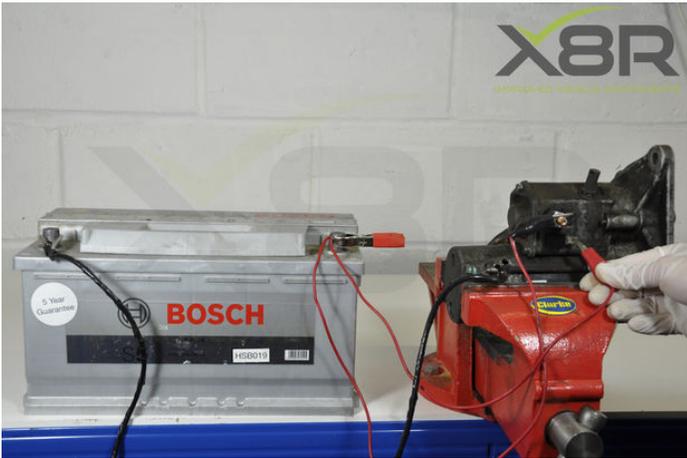
### Step 2: Testing the starter motor on the bench

To test you will need 3 wires from the battery to the starter. 2x positive 1X negative. Black being the negative connection and Red being positive as shown here.

Connect the negative cable, the black cable shown on the negative terminal of the battery to the long bolt that goes through the starter motor, this is made of steel which will give you the earthed connection you require.

Connect one of the positive leads, shown in red, to the positive terminal of the battery as well as to the bolt on the starter that has the power cable fitted when on the vehicle.

With the other positive cable from the battery very briefly touch the connector situated on the side of the starter. If the starter is functioning this will fire the starter motor up and the gear will spin. If not the terminals and plunger should be replaced.

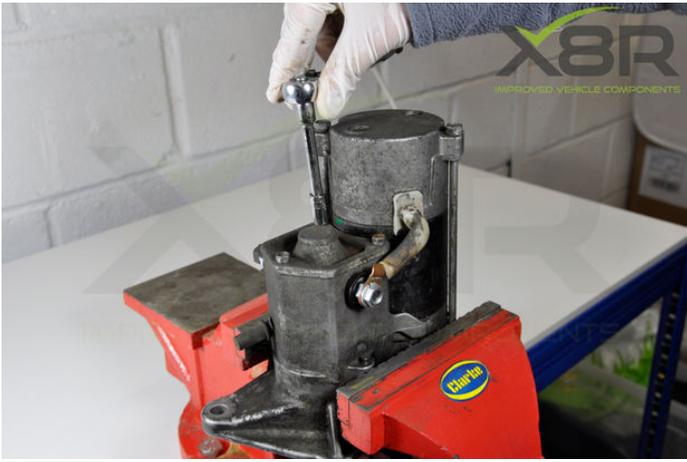
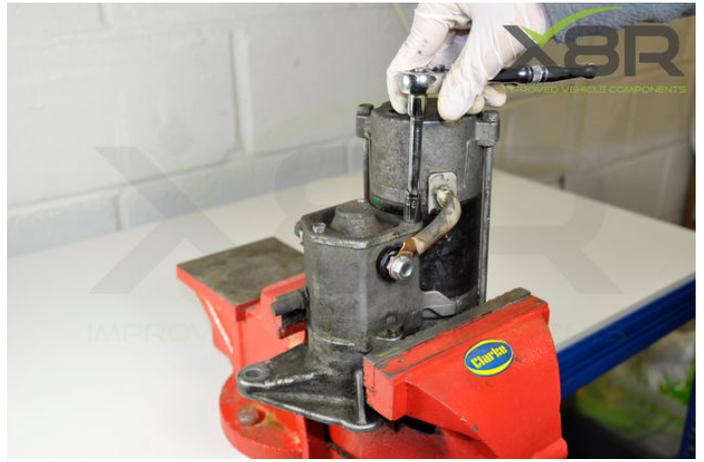
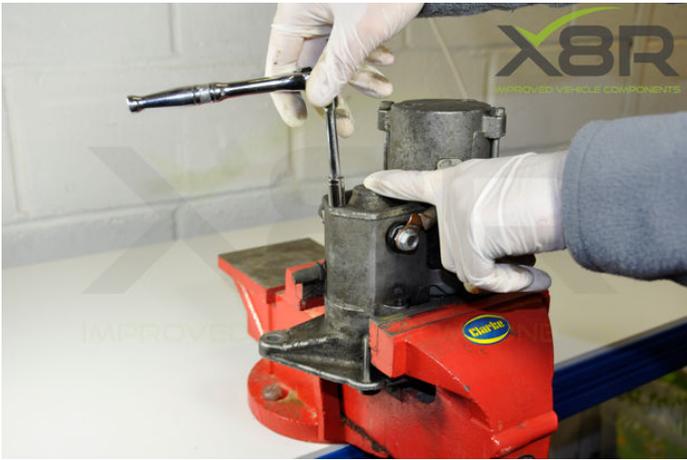
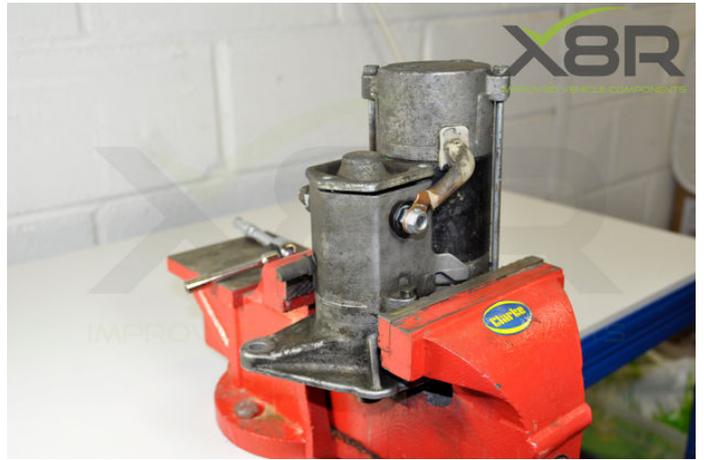
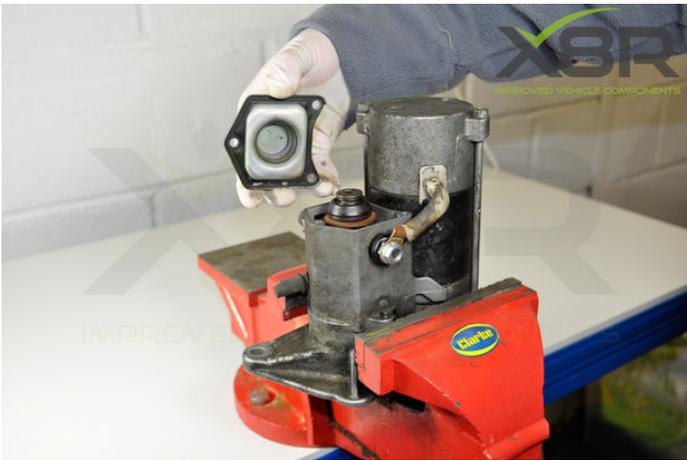
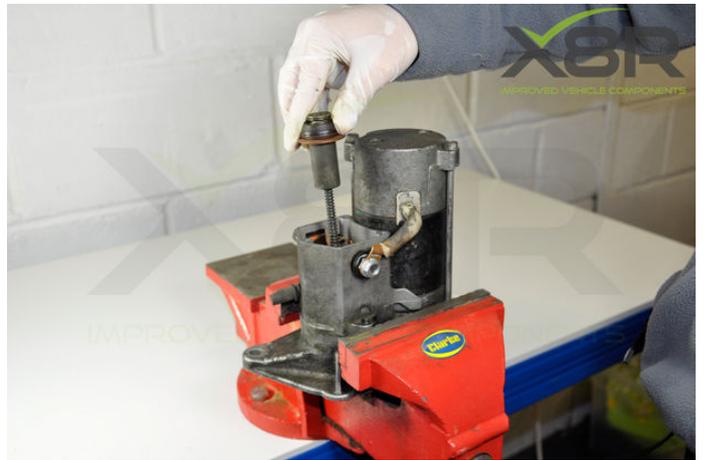
### Step 3: Removal of solenoid housing cover and plunger

Start by clamping the starter in a vice with the gear facing down.

Remove the 3x 8mm bolts from the end cover, when undoing the last bolt the cover will start lifting, to prevent it from popping off it is best to keep a finger on the cover while removing the last bolt.

Lift the cover off.

Remove the plunger from the starter motor with the spring.

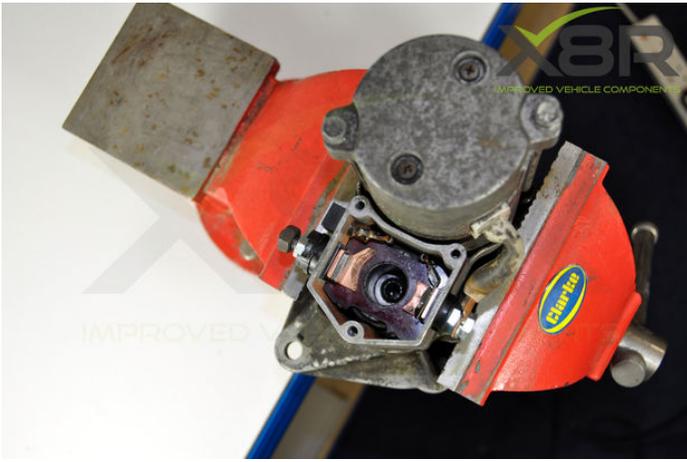
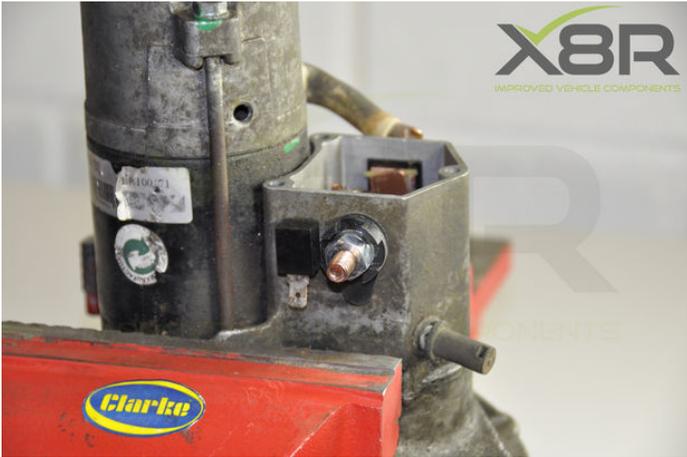
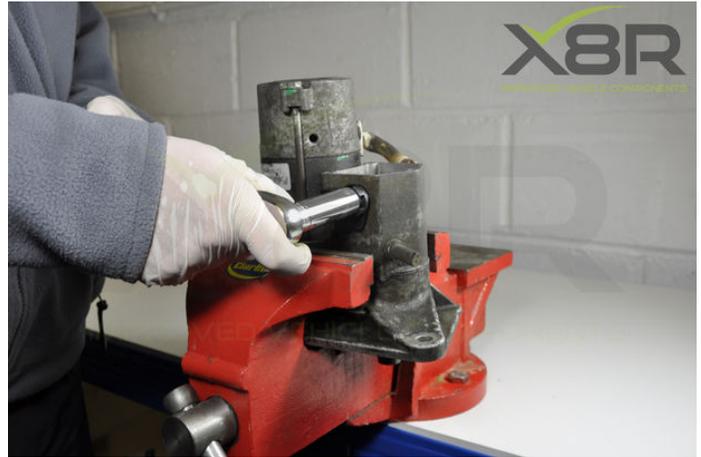
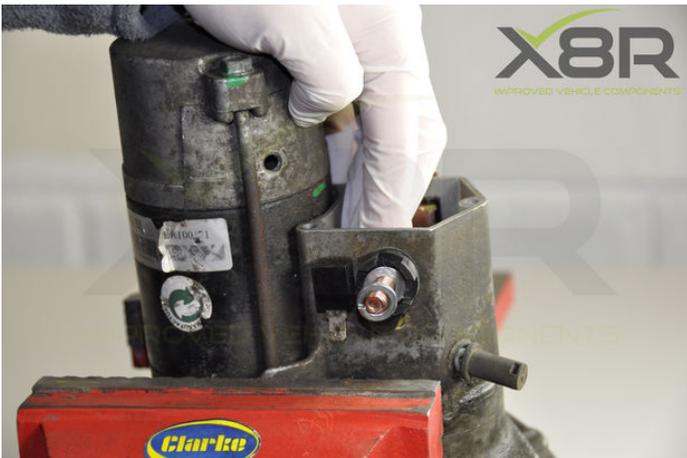
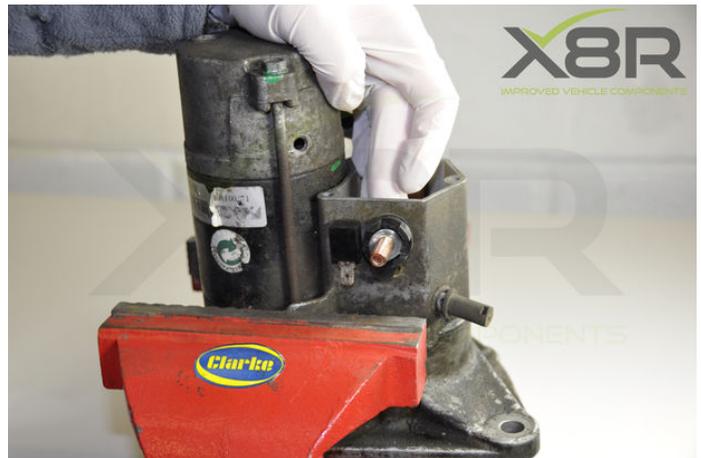
#### Step 4: Removal of the first contact

Remove the 14mm nut and washer, the plastic spacer/locator and the O ring behind it.

Now from the inside of the starter motor you will be able to remove the bolt and contact.

Remove the plastic locator that sits inside, this goes through the bolt hole, this will just pop out from the inside.

Replace the components removed with our new components in the same order.

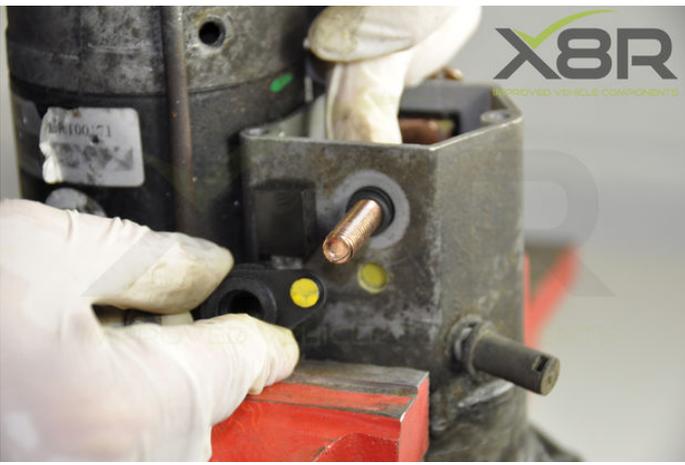
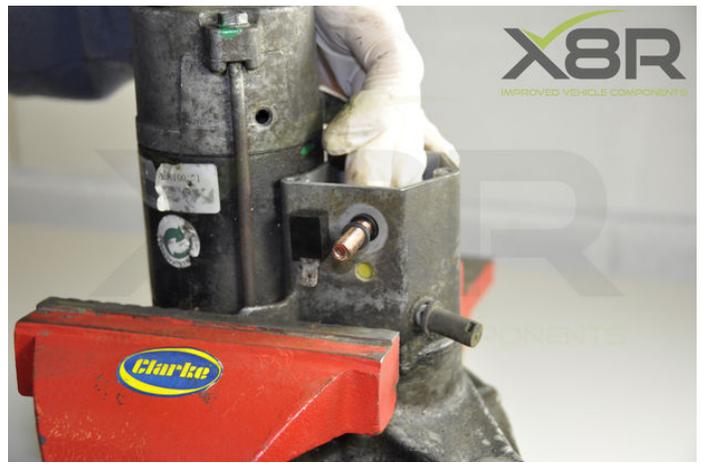
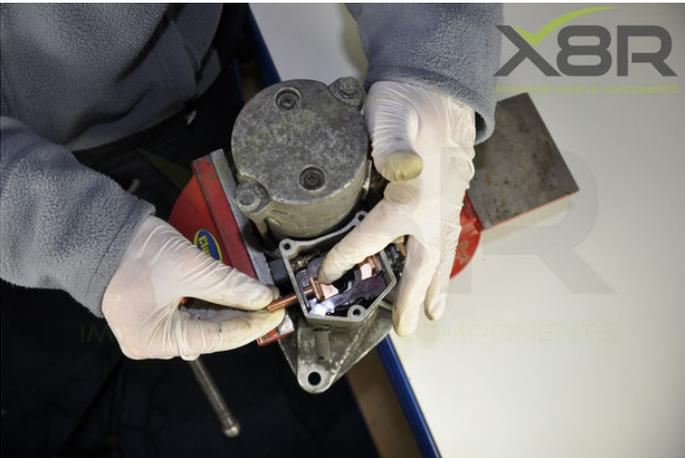
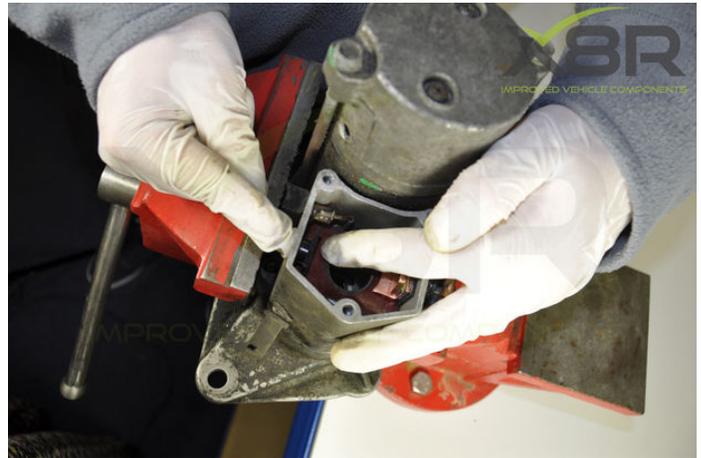
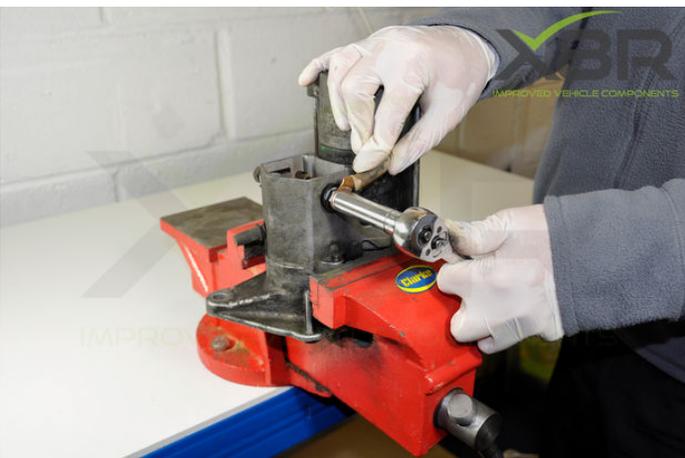
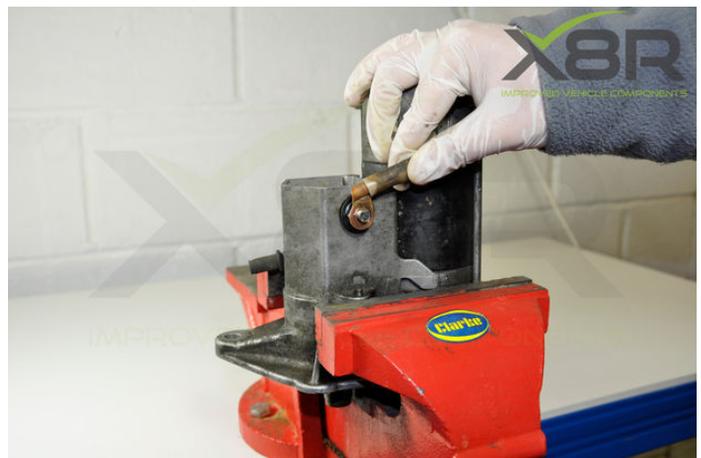
### Step 5: Removal of the second contact

Remove the 12mm nut and the wire on the bolt that goes into the side of the starter motor, gently slide the wire off of the bolt.

Behind the wire will be a 14mm nut, once removed, there will be a metal washer and a plastic spacer, remove these to find a small O ring.

Now from the inside of the starter you will see the contact/bolt and a wire with a connector, hold the connector and try pushing the bolt out. If it does not move, get a small flat headed screwdriver. Holding the connector again, lever the bolt out.

Now with the bolt out of the way you can push the connector back, exercising caution, you will now be able pull the contact out.

Like the other side, there will be a plastic locator behind the contact, this will just pop out.

Replace the components removed with our new components in the same order.

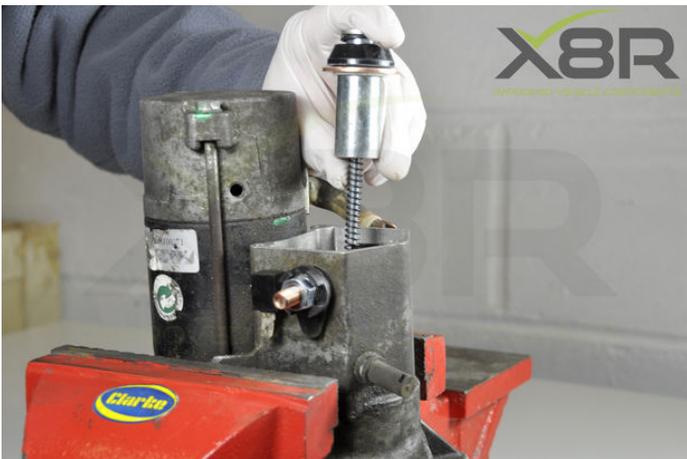
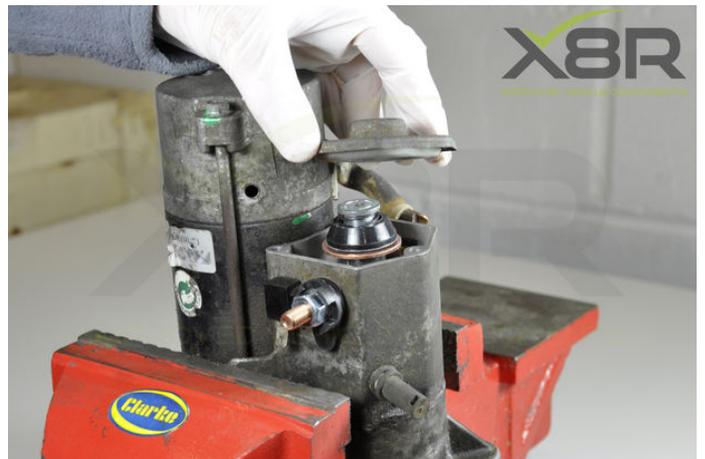
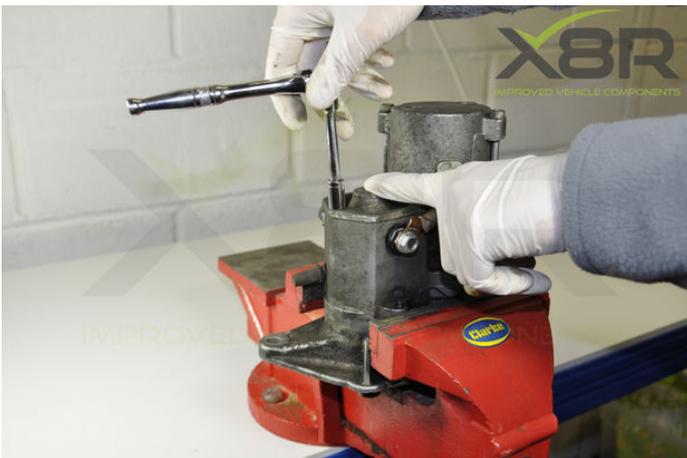
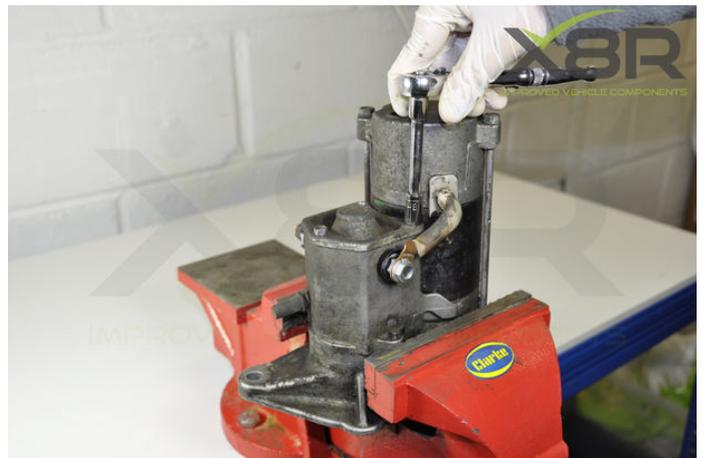
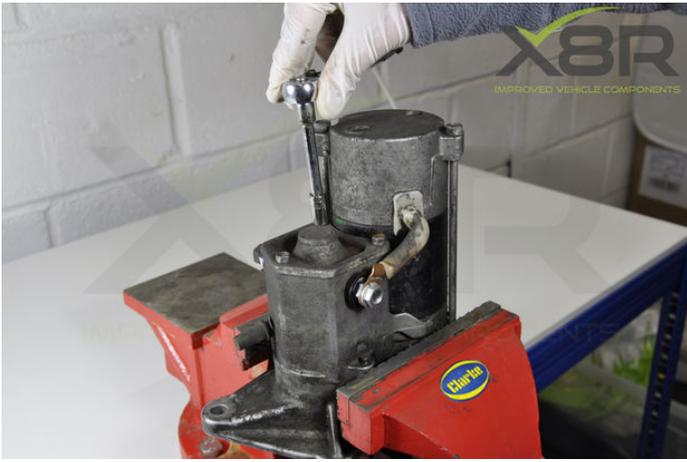
### Step 6: Refitting plunger and cover

Insert new plunger remembering spring in the same way as the old plunger.

Refasten end cover.

Using the same method as in Step 1, test the starter to check install has corrected the issue, starter should fire up and gear should turn and engage.
