P38a Clarion PU9836A Common fault repair.

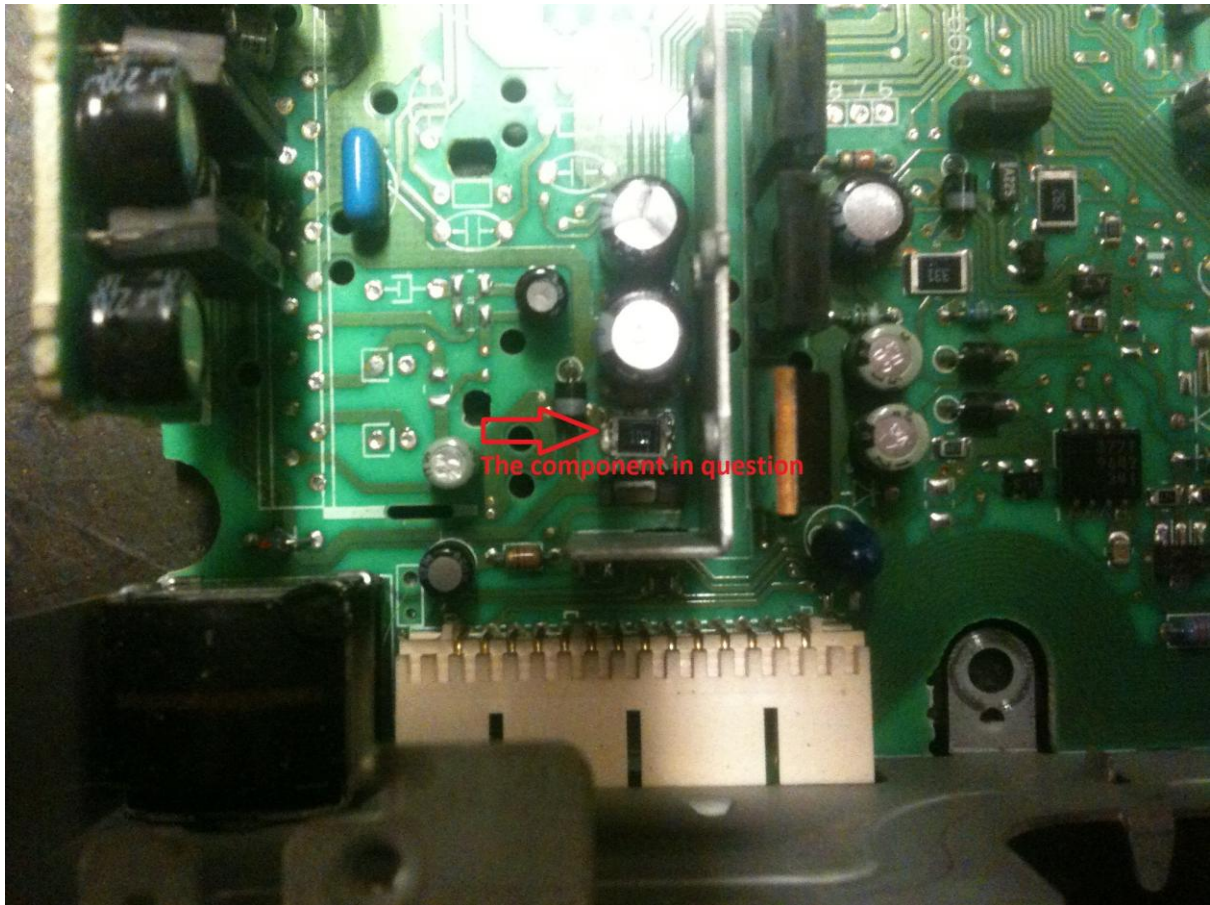
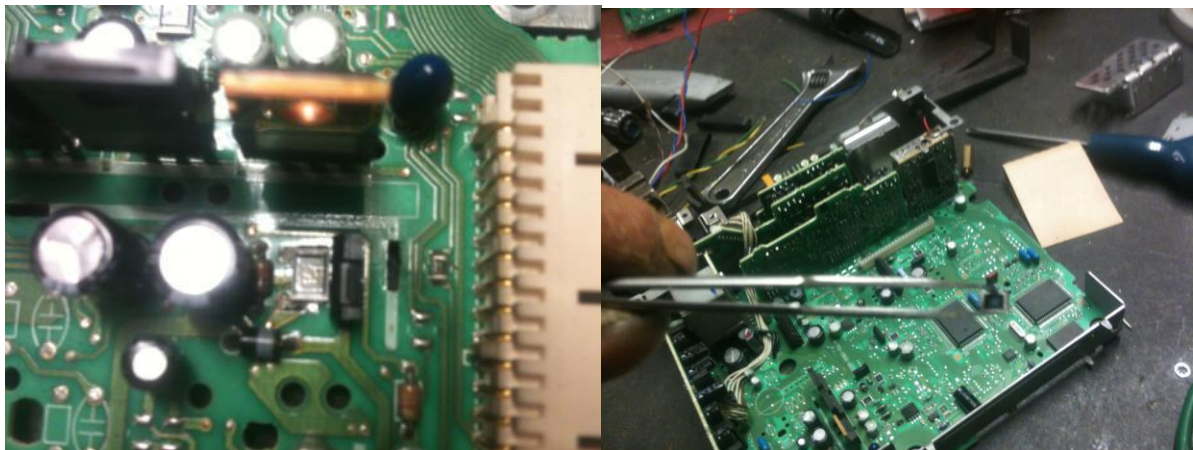
6. Now for the part that causes all the buzzing and no sound. Its a tiny resister. When i touched the souldering iron to the left side of it as you look at the front of the radio, it fell off. This is what you have to solder back on, and its very fiddly to do. Again dont put too much heat in. I used tweezers to get in back into place, then held it down with the tweezers. With a fine tip on the soldering iron I put a small blob of solder on the tip, then transfered the solder to one end, then the other. At the same time i went around and resoldered any connections that looked weak or poor.

And in the haynes style of writing refitting is the reverse of removal, make sure you resolder the twist tabs on the bottom where the plate goes through the board.
