PUBLISHED: 11-MAY-2011  
2011.0 RANGE ROVER (LM), 303-01A

ENGINE – TDV8 4.4L DIESEL

# OIL COOLER (G1346501)

## REMOVAL

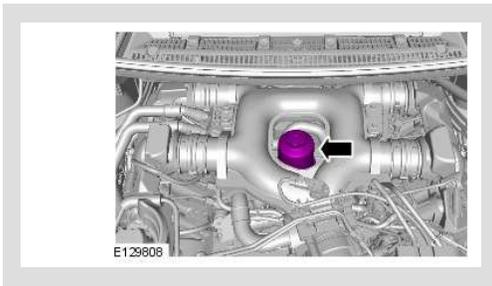
- 2.

- Loosen the oil filter cover 3 turns and allow the engine oil to drain.

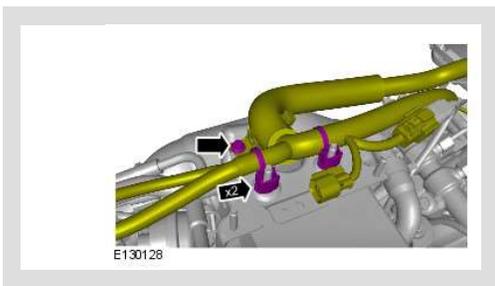
5.

*Torque: 10 Nm*

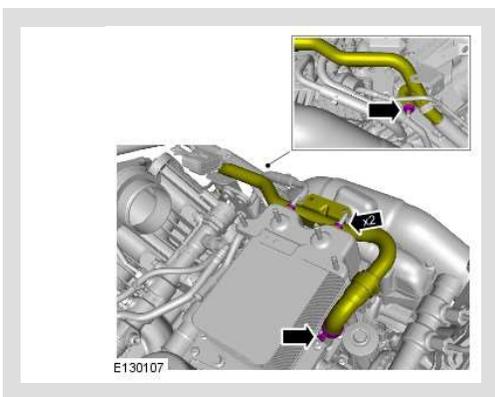
6.

Make sure that all openings are sealed. Use new blanking caps.

*Torque: 10 Nm*

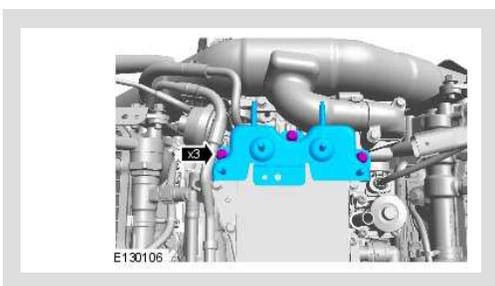
7.

*Torque: 10 Nm*

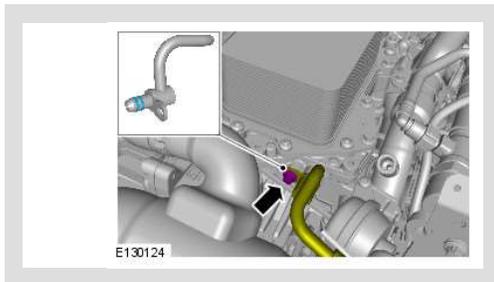
8.

- Be prepared to collect escaping oil.
- Make sure that all openings are sealed. Use new blanking caps.

*Torque: 10 Nm*

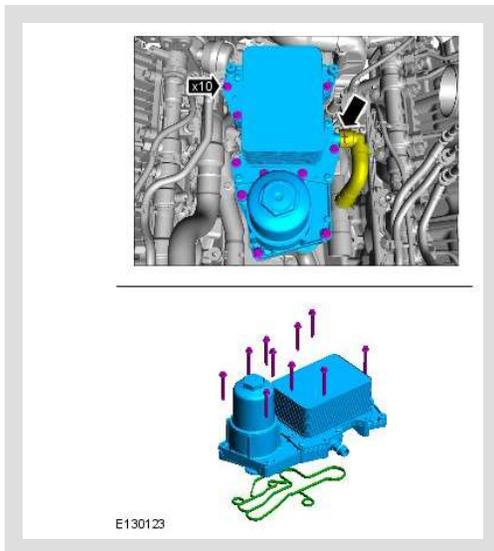
9.

- Be prepared to collect escaping oil.
- Be prepared to collect escaping coolant.
- Make sure that the mating faces are clean and free of foreign material.
- Make sure the seal is installed correctly.

*Torque: 13 Nm*
